WK181 10K Endurance Test Full Review

A Canadian Firearms Endurance
Testing Report

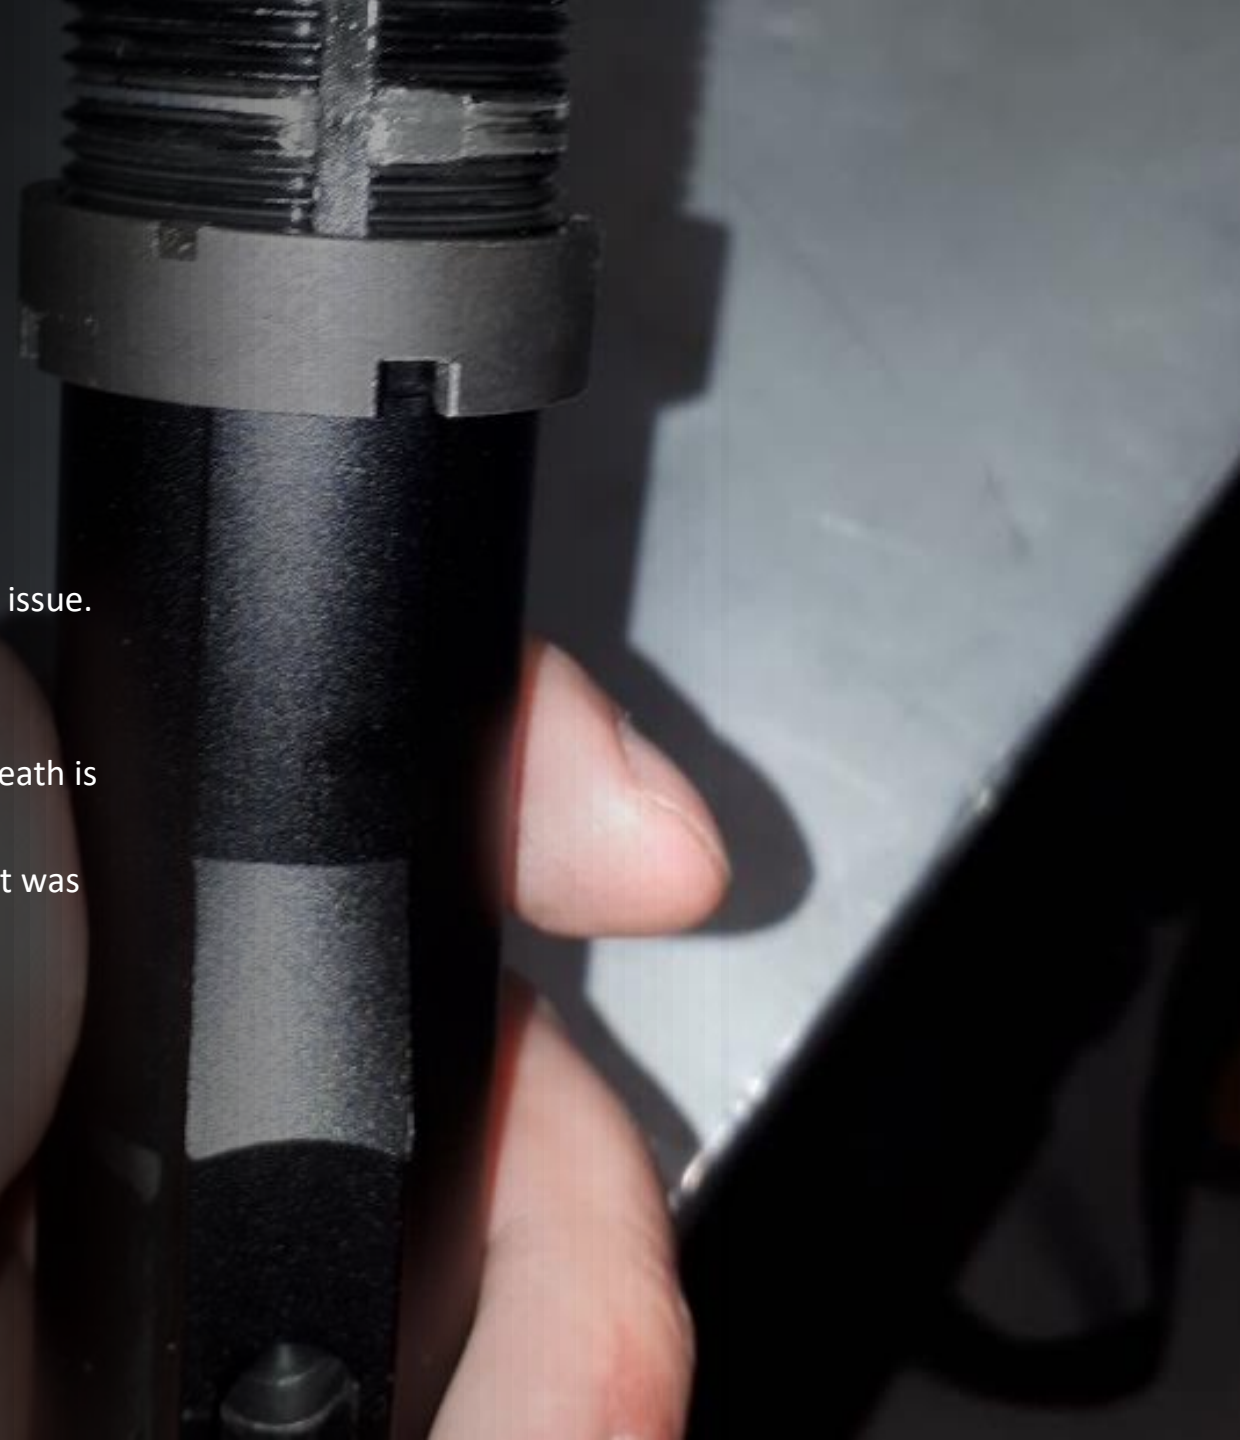
Durability (3) – The buffer tube

We initially suspected the buffer tube had broken before breaking 5000 rounds, it was then confirmed at approximately 7000 rounds

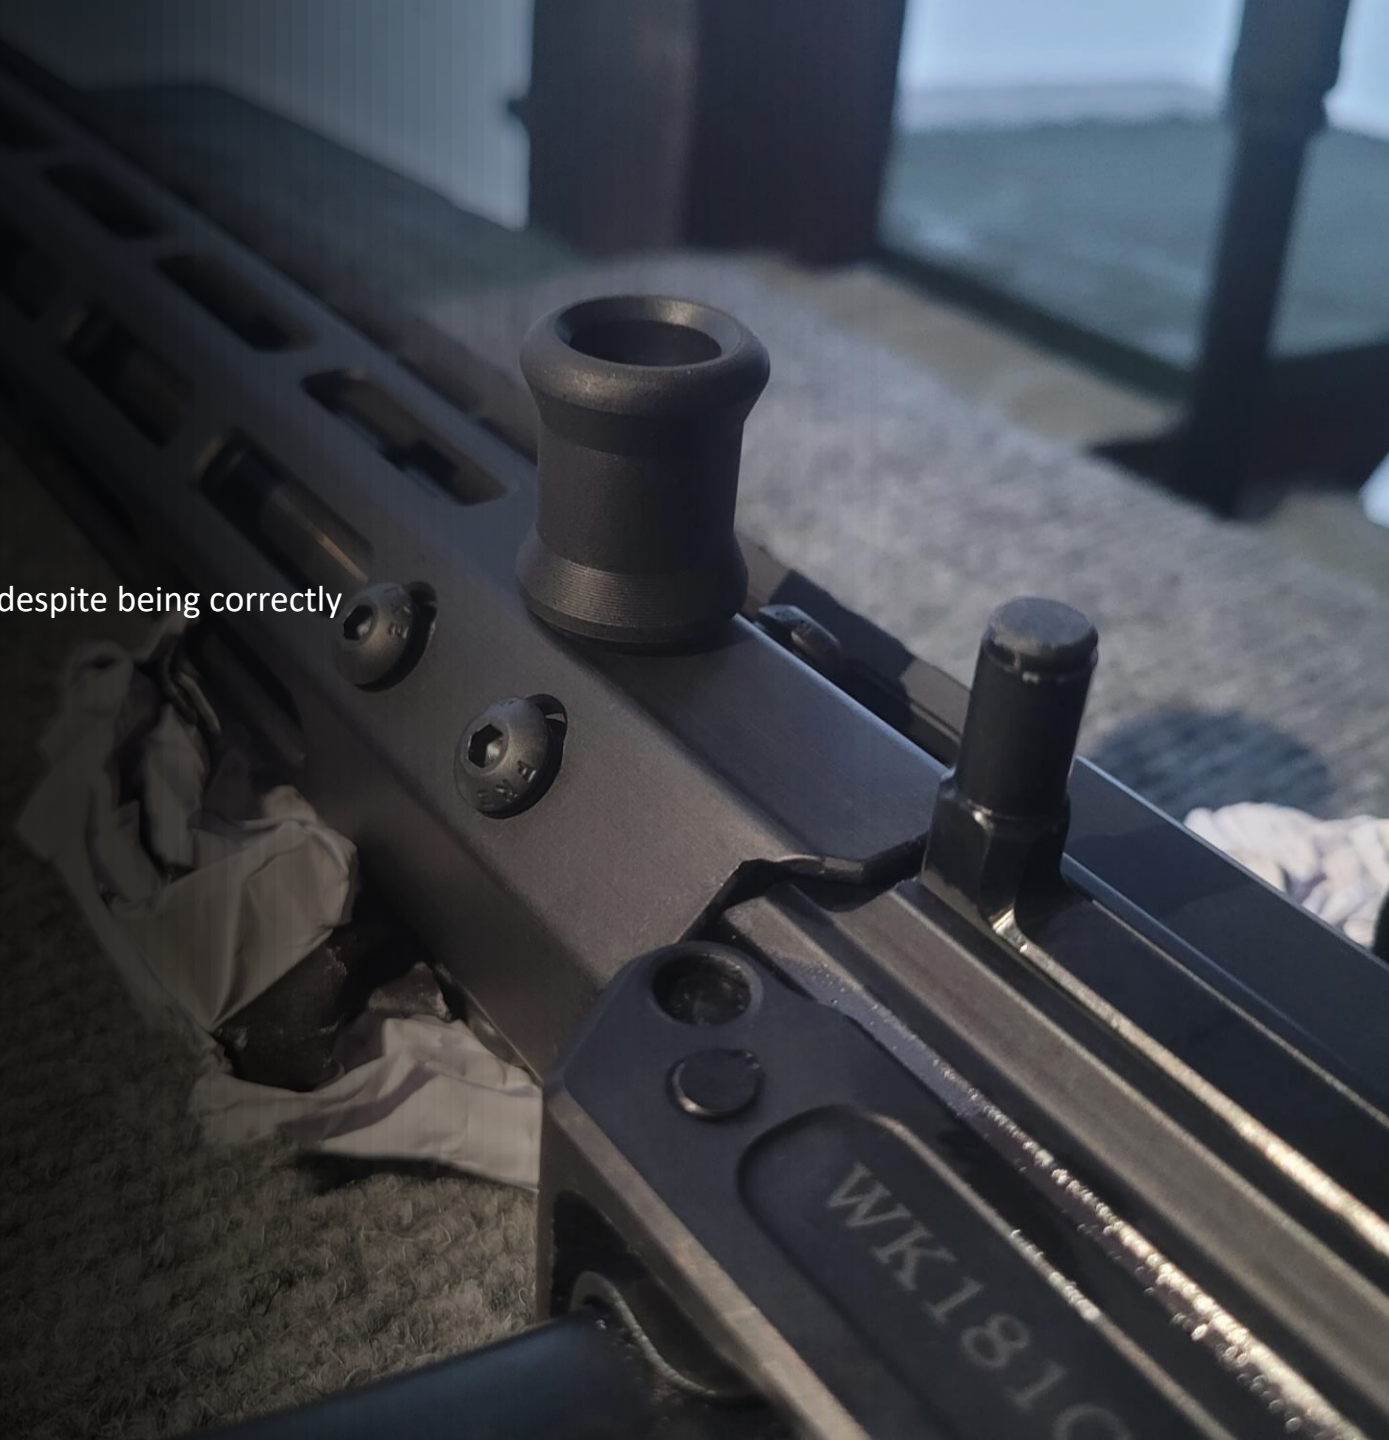
Durability (4) – The pistol grip

Over 10,000 rounds the pistol grip came loose on numerous occasions despite being correctly assembled and tightened.

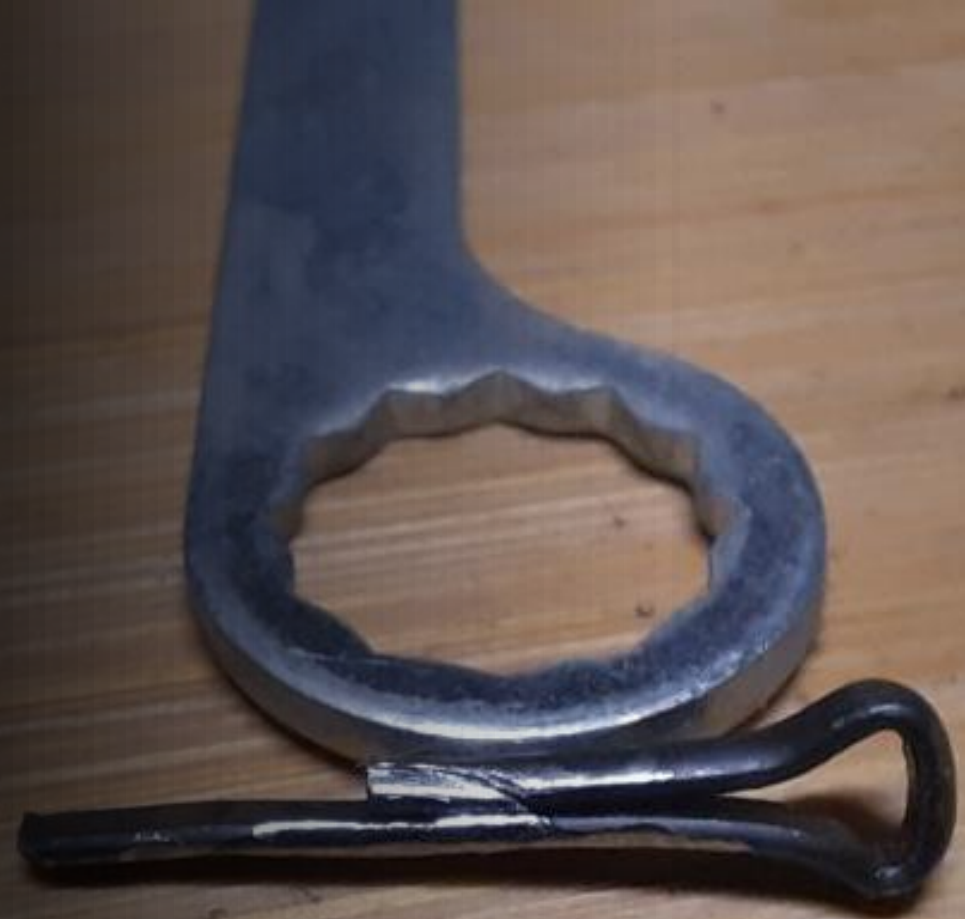
Durability (7) The cotter pin

At 7865 rounds the firing pin retaining pin (A cotter pin) broke causing the rifle to completely fail and be unable to fire again safely.

Additionally, after replacing the retaining pin with a new one and firing a few hundred more rounds, the new retaining pin indicated signs of wear again suggesting that this is a component that should be checked and possibly replaced ever few thousand rounds

Cheap cotter pin should be replaced with a higher quality one

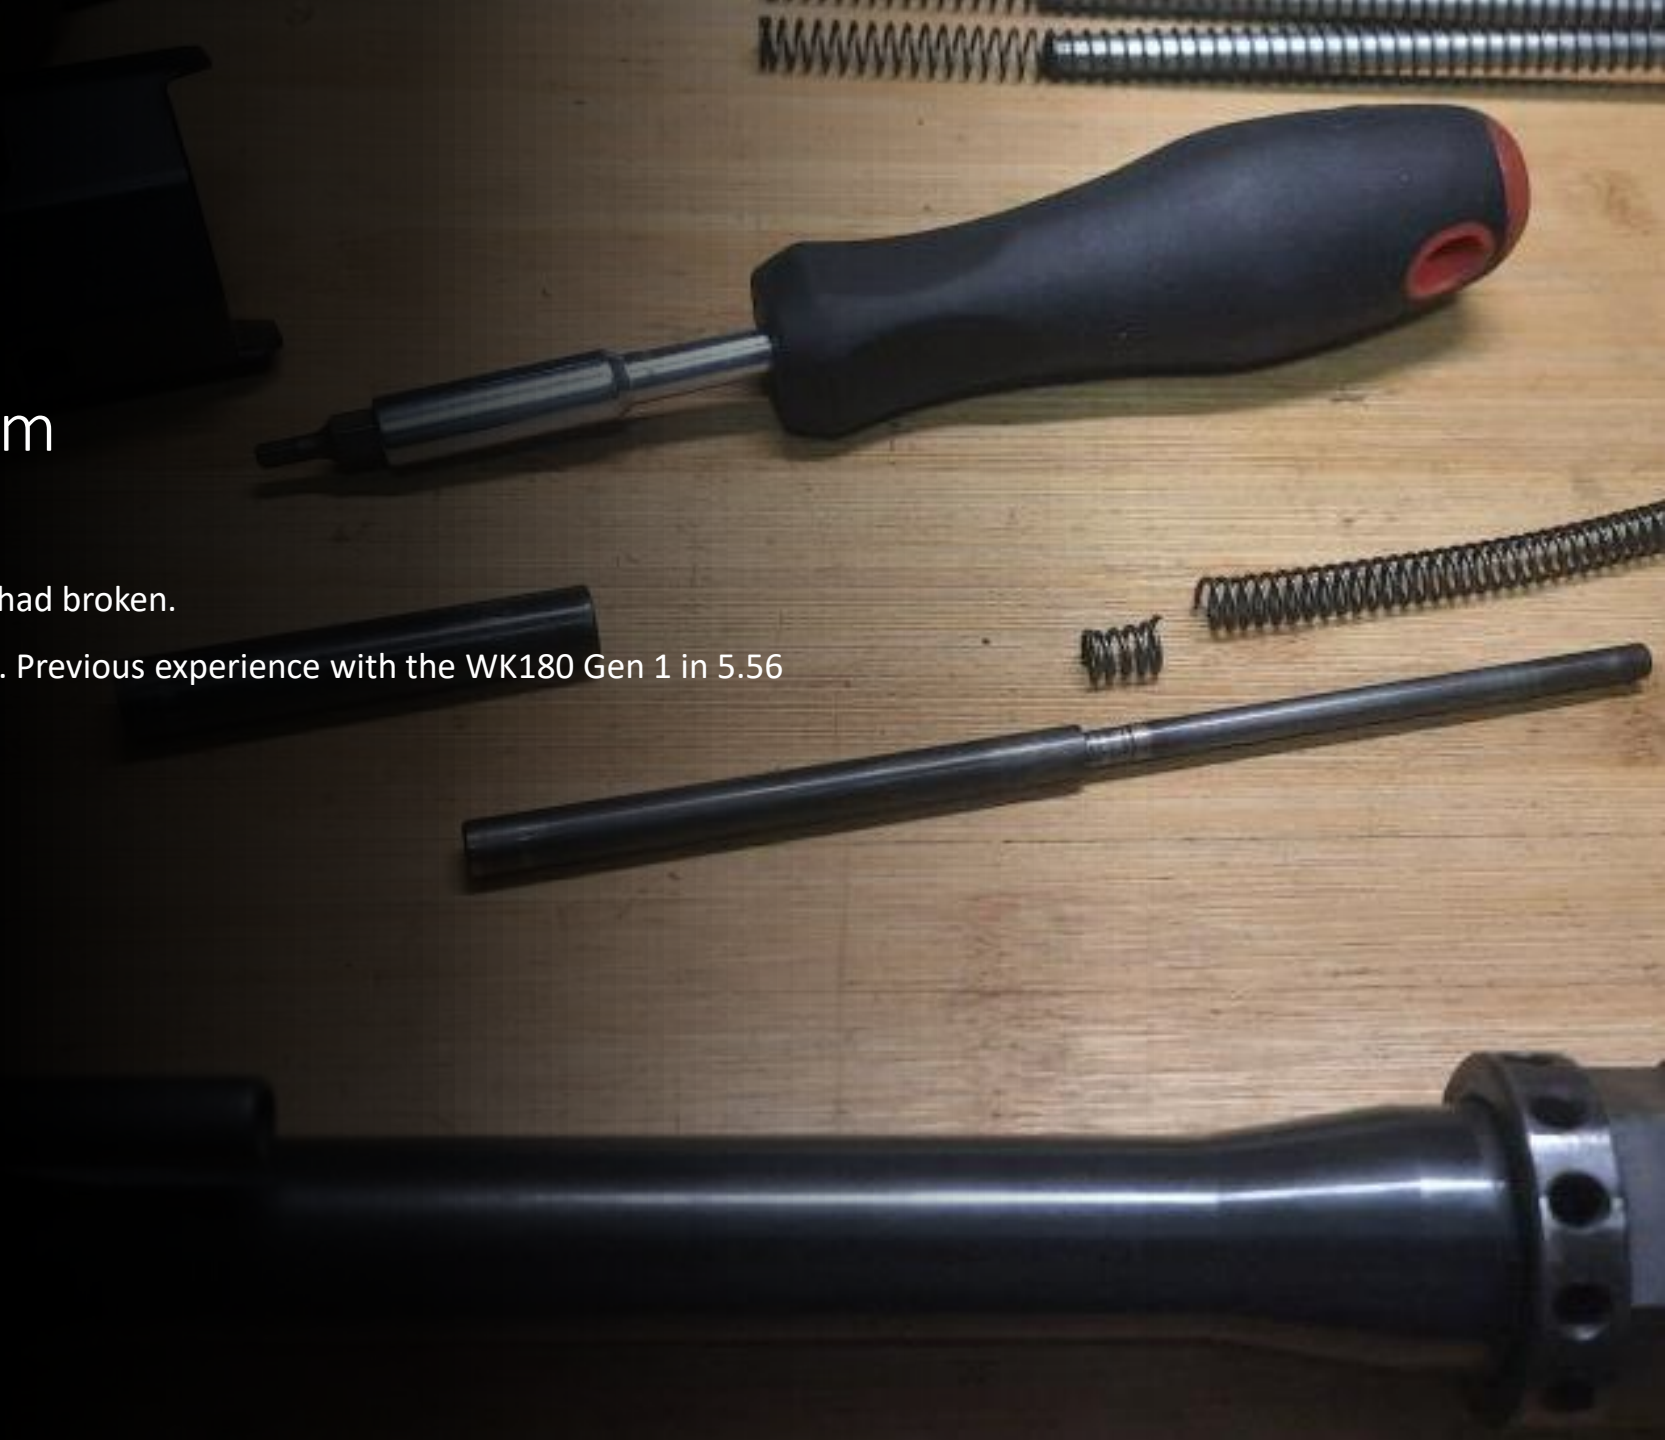
Durability (8) The gas system

At 8730 rounds it was noticed that the piston spring had broken.

No impact on the functionality of the rifle was noted. Previous experience with the WK180 Gen 1 in 5.56 with a broken spring added to this determination

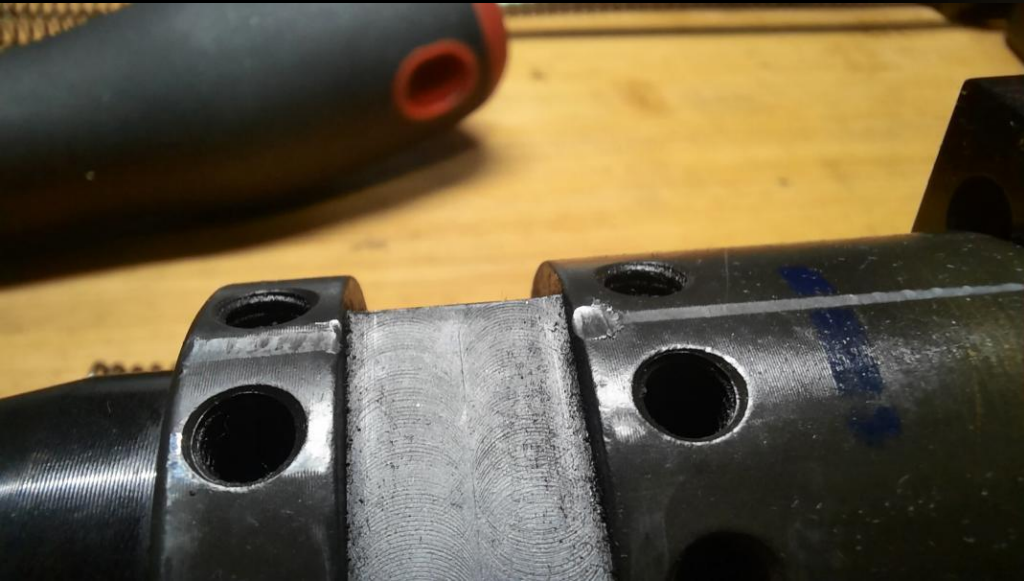
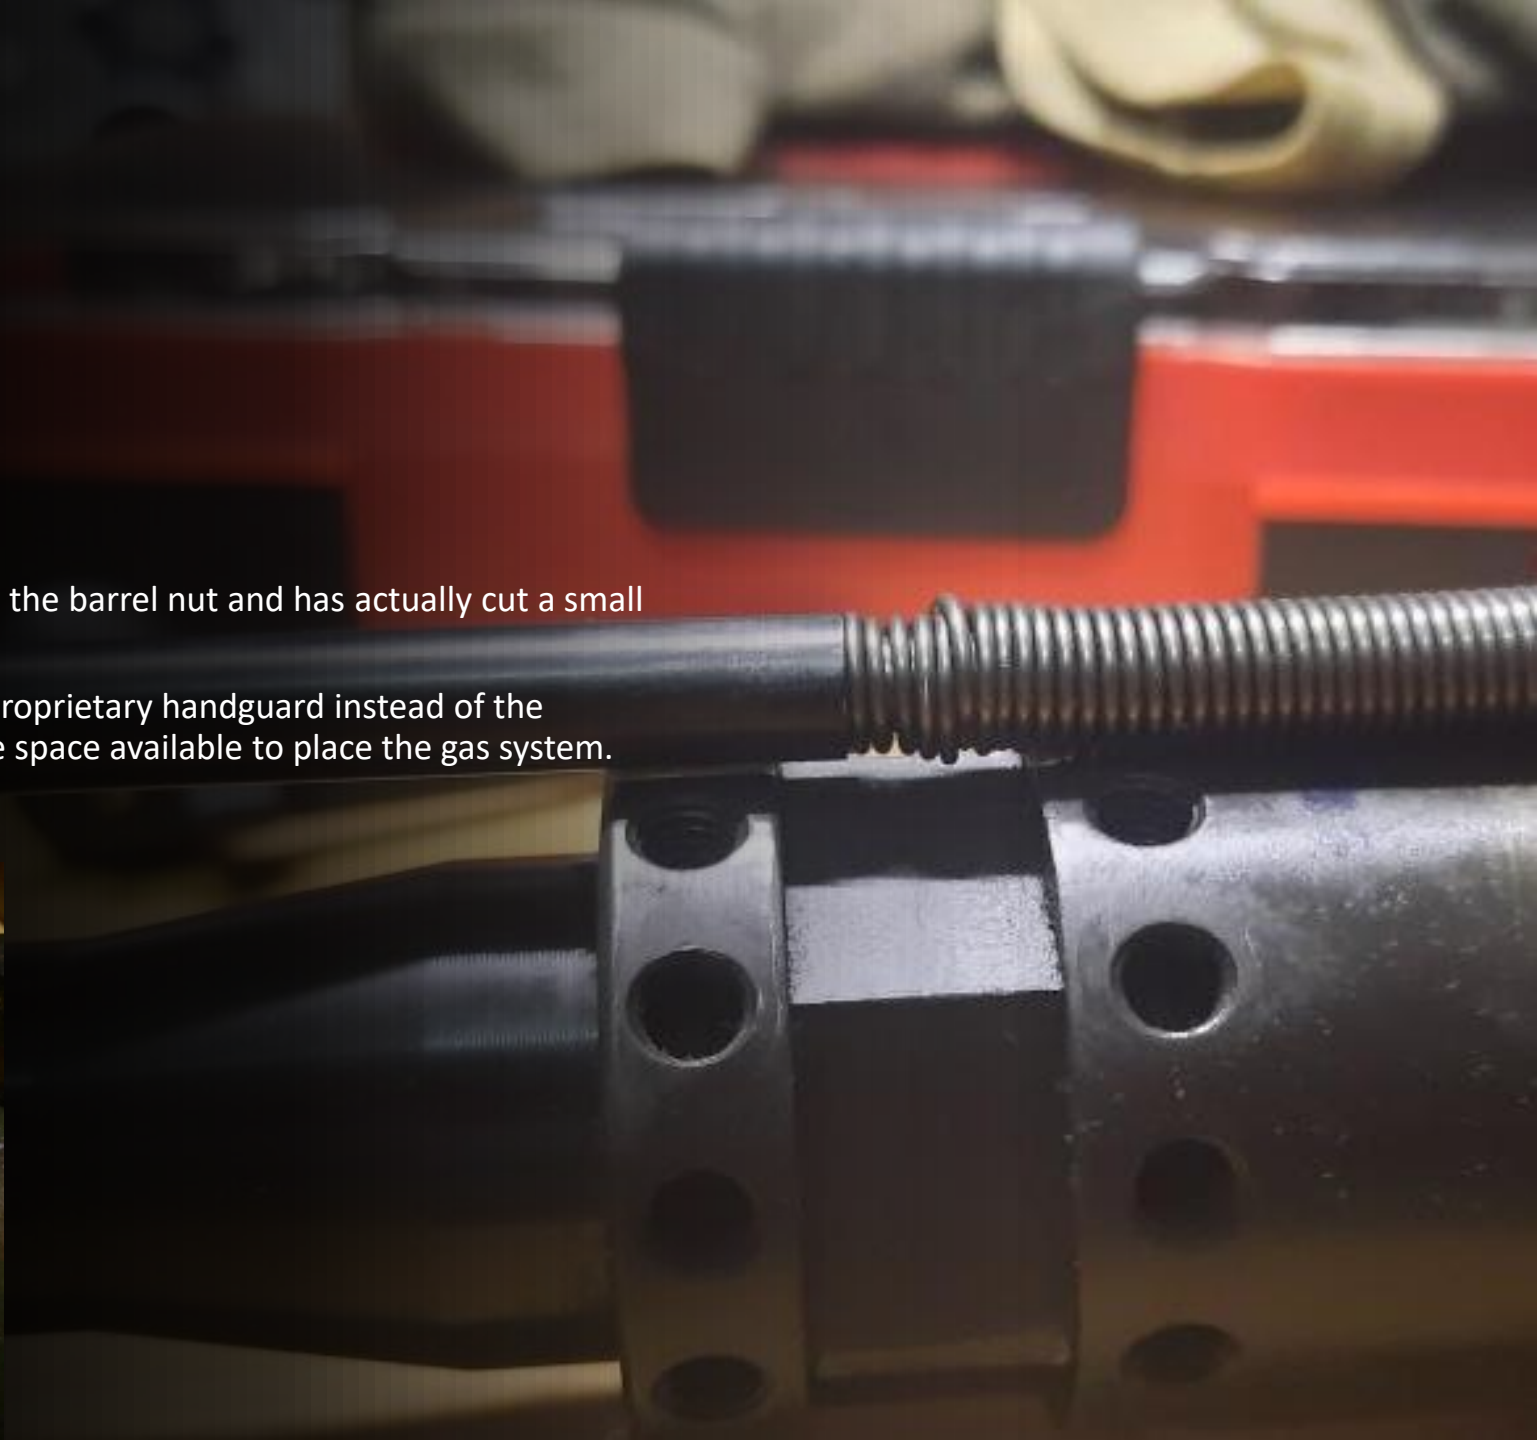
Durability (9) The gas system

It is noted that on compression the piston spring rubs against the barrel nut and has actually cut a small groove into it.

This is likely a continued symptom of trying to avoid using a proprietary handguard instead of the standard AR15 handguard. The use of which greatly limits the space available to place the gas system.

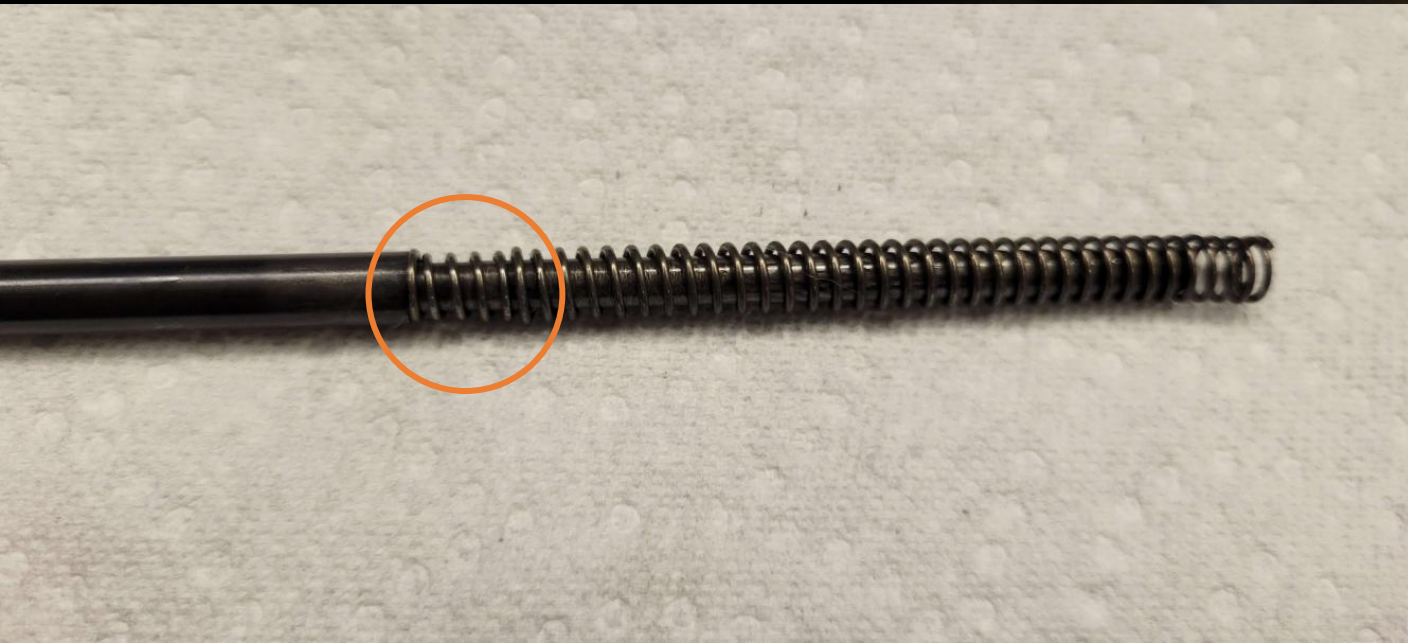
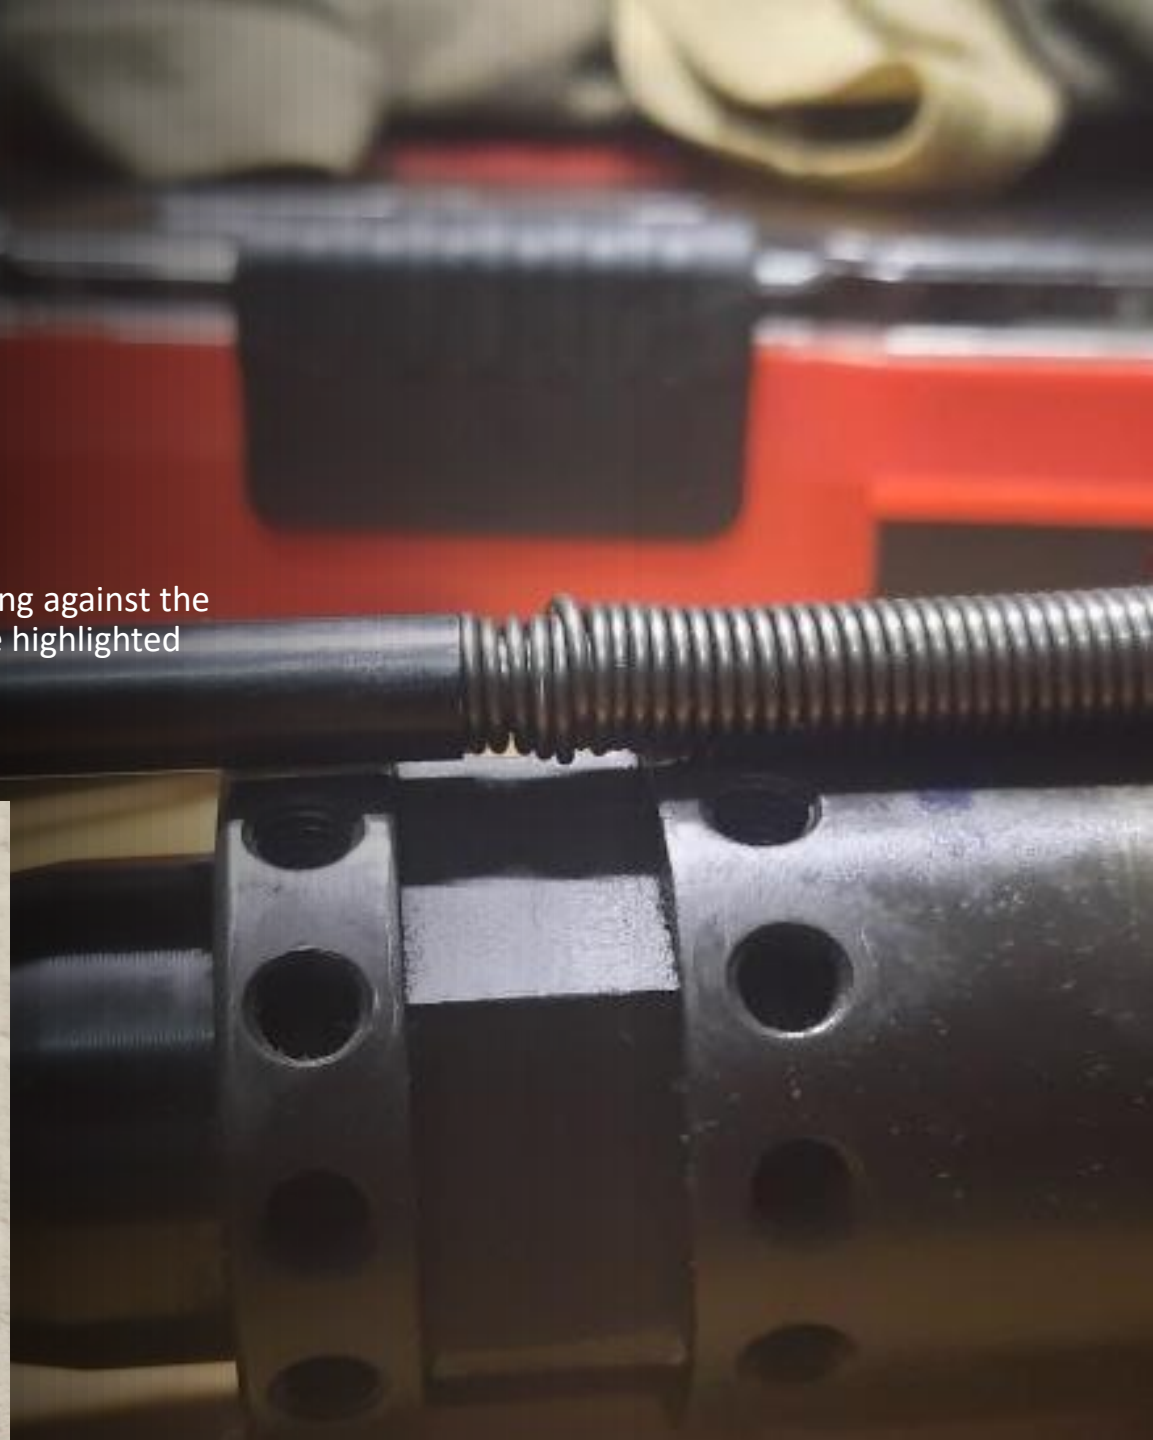
Durability (10) The gas system

It was also noted that the piston spring may be being stretch during use from it's rubbing against the barrel nut. Looking at where the first piston spring broke it was in a similar place to the highlighted stretched area

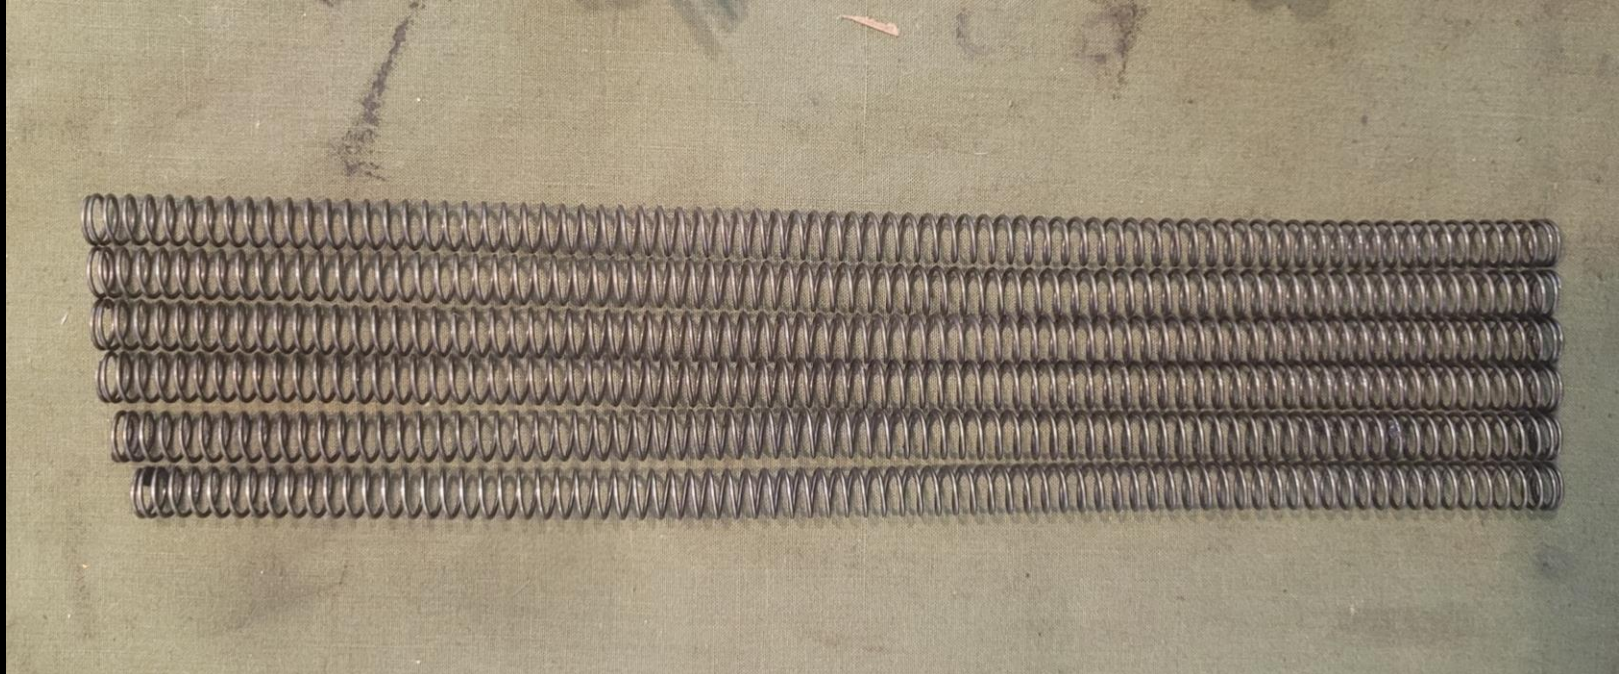
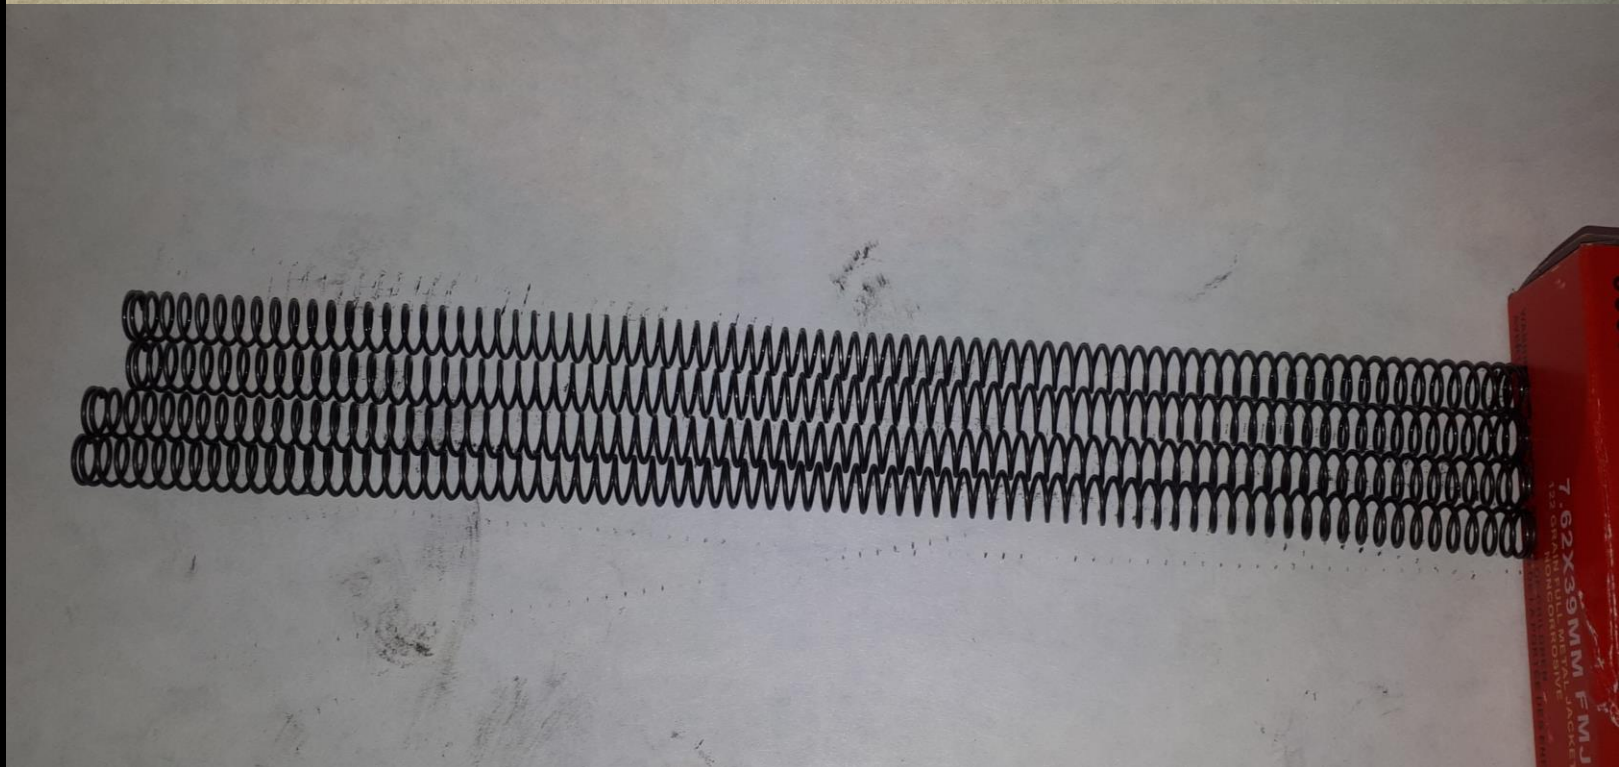
The Spring Issue (5)

Top image: The bottom 2 springs after 4476 rounds compared to unused springs

Bottom image: The same springs after 6800 rounds

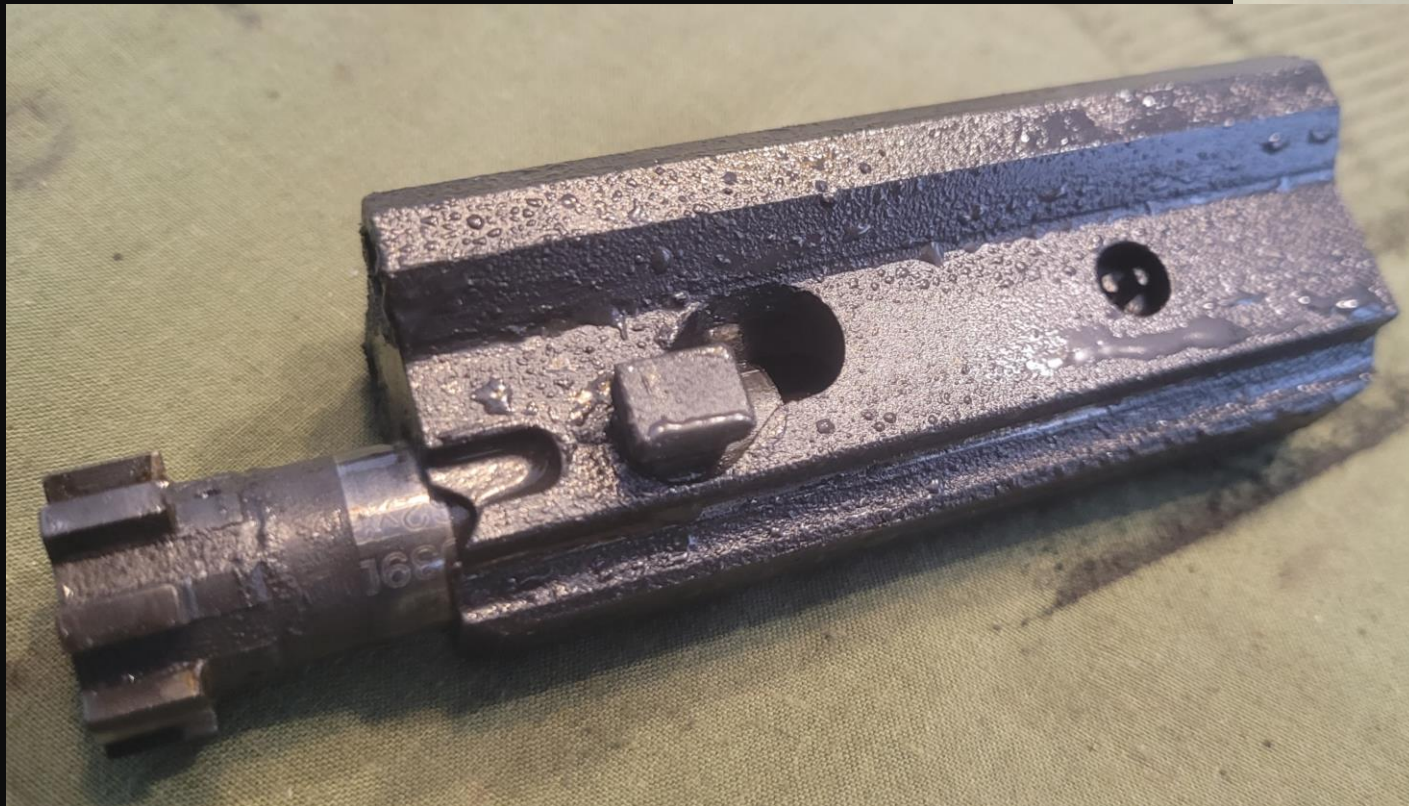
The rifle after 4476 rounds and 3226 without cleaning (1)

Water due to snow melt from cooling the rifle down

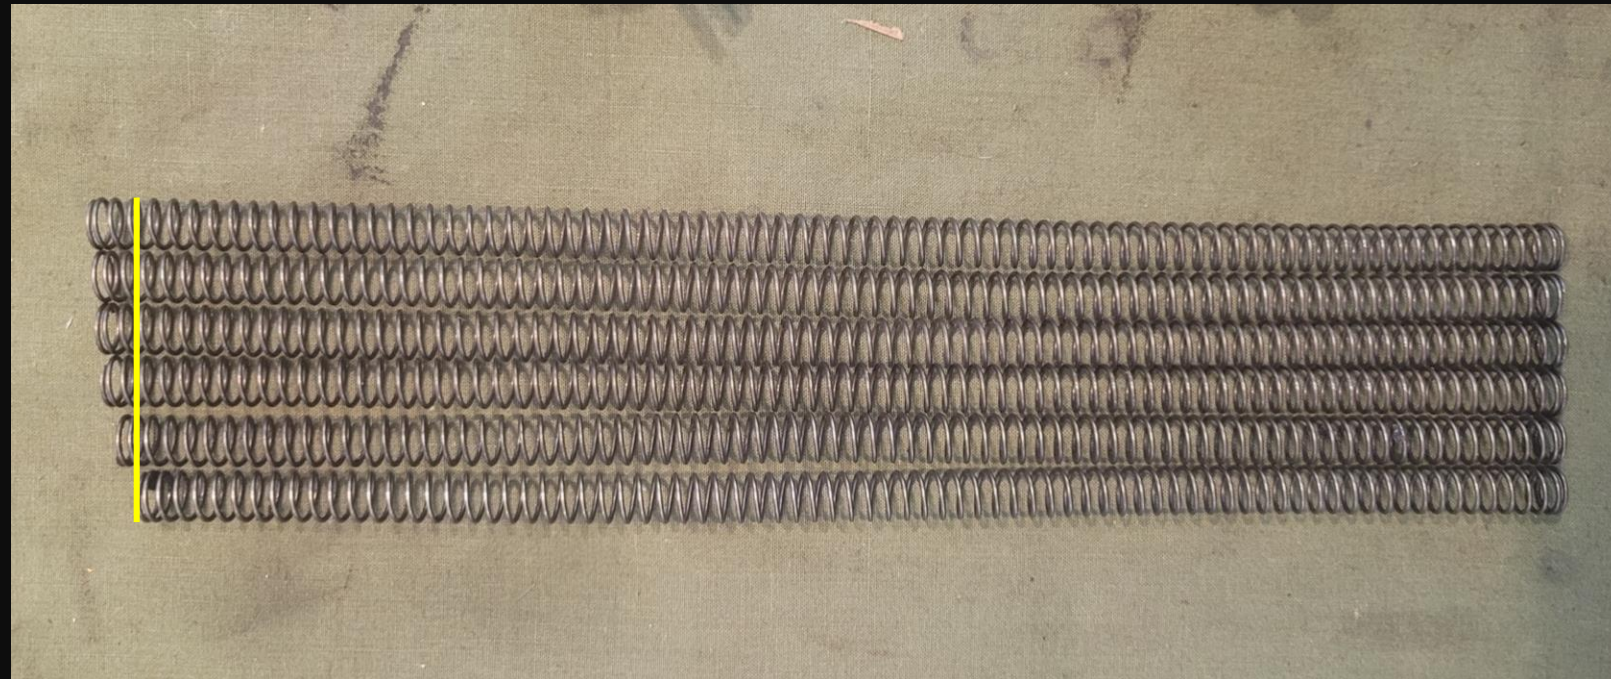
The rifle after 4476 rounds and 3226 without cleaning (2)

The recoil springs have started to shorten (Bottom 2 are WK181 springs, remainder are un-used 180 springs)

On the WK180 this contributed to the gun self-disassembling while shooting

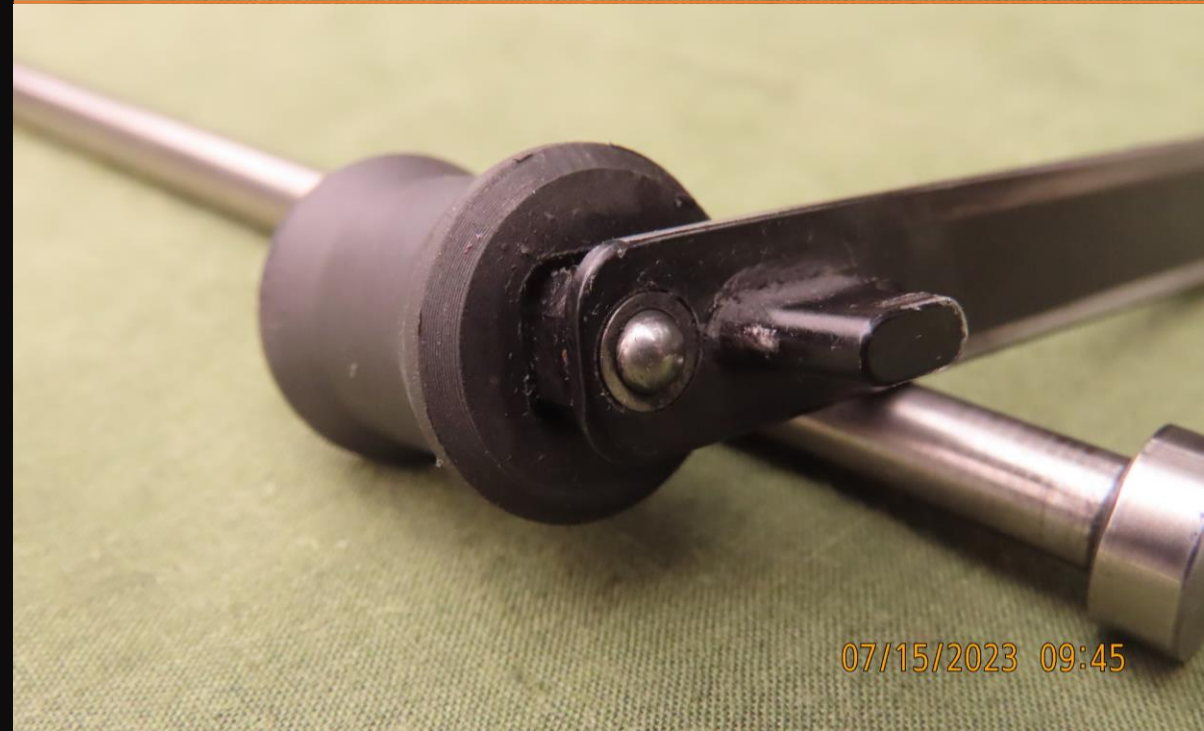
Cocking handle (NB: This is not the original, the first was replaced after the plastic cover came off within <1000 rds)

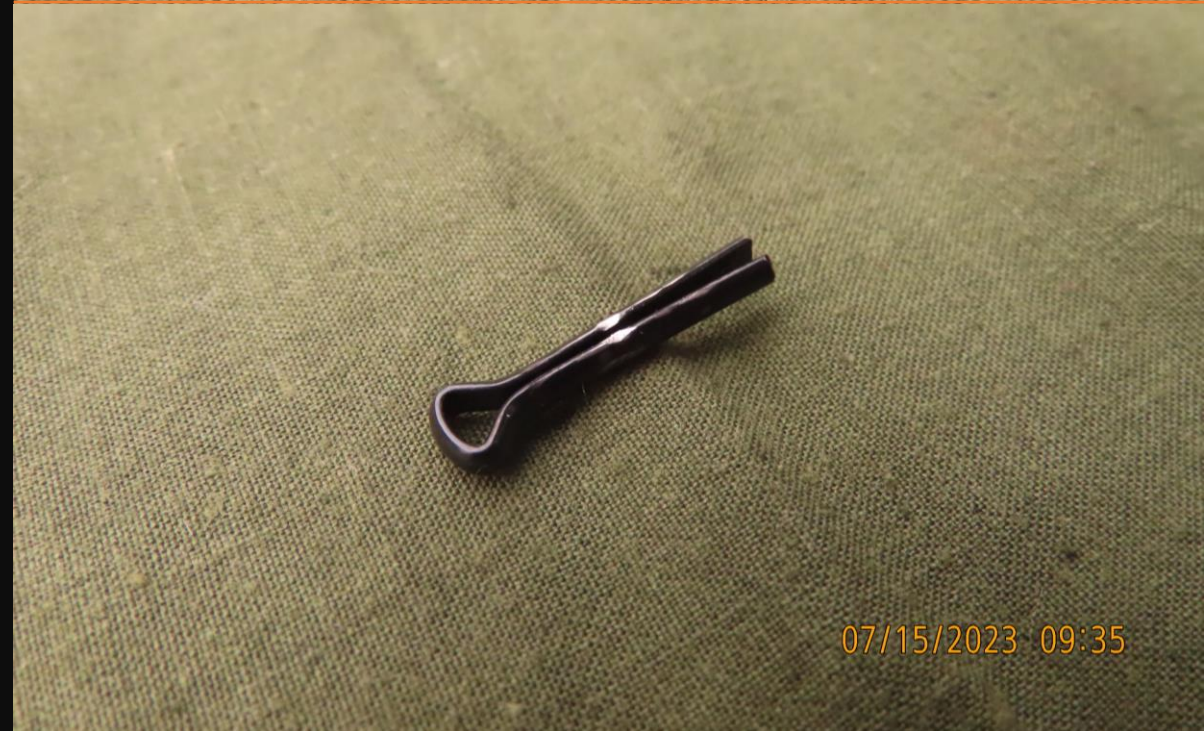
Firing pin and Cotter pin (which had equal wear on both sides and was a replacement part after the first broke)
