WK181 10K Endurance Test Full Review

A Canadian Firearms Endurance
Testing Report

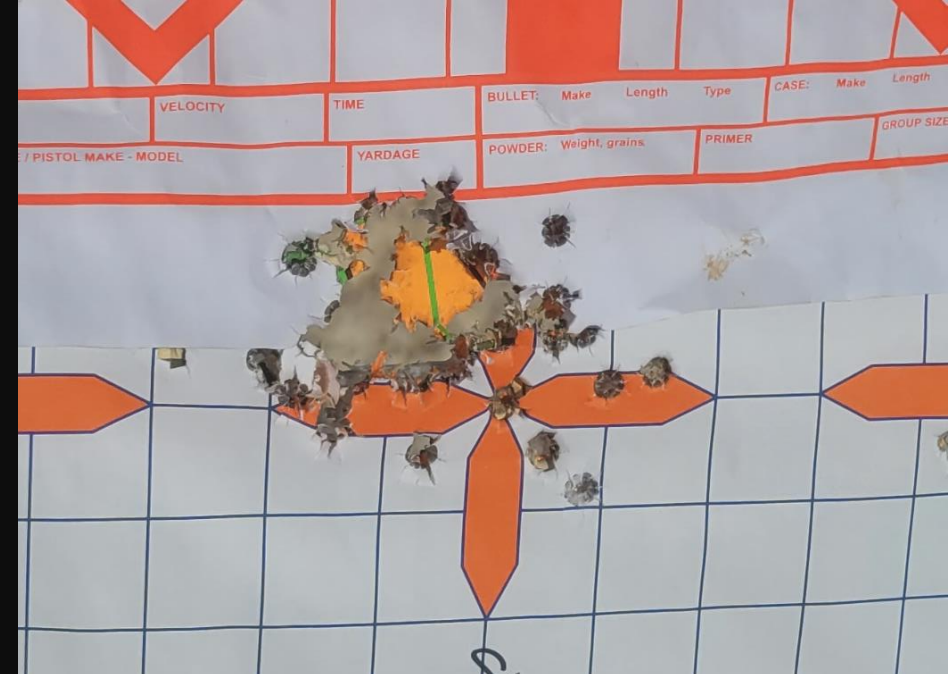
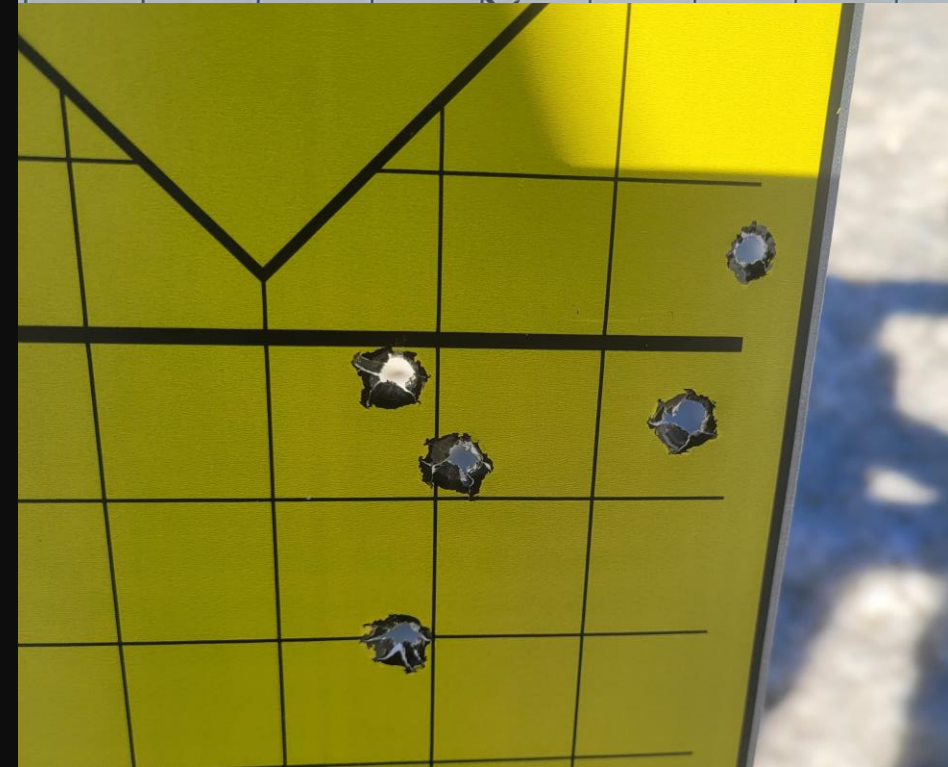
Accuracy 0 – 5000 (2)

POI did not shift significantly through extended firing, the top image shows a 50 round group shot at 100m without great effort toward precision

After firing 400 rounds non-stop we shot a 5 round group using Chinese surplus and achieved a 3moa group as can be seen on the yellow target

NB: On the 50 round group it was known that the rifle was shooting high and left of POA, one should focus on the distribution of shots not the location of the group

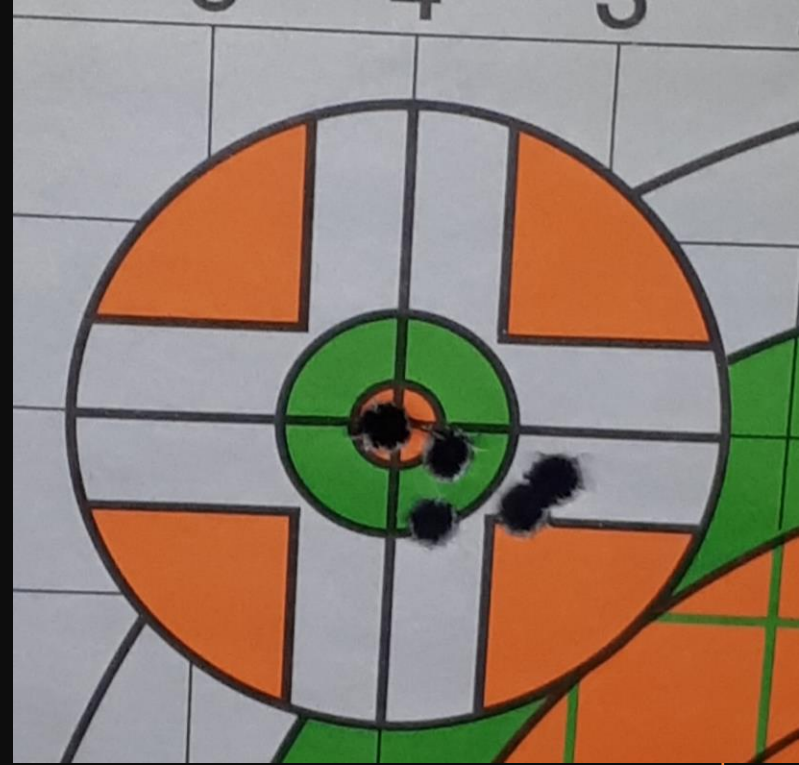
Accuracy 5000 – 7500 (1)

Pictured: A 25m quick 5 round group using a 1x magnification old optic and Chinese surplus ammunition at 6800 rounds with a hot barrel from an unstable position. Approx 3.5moa

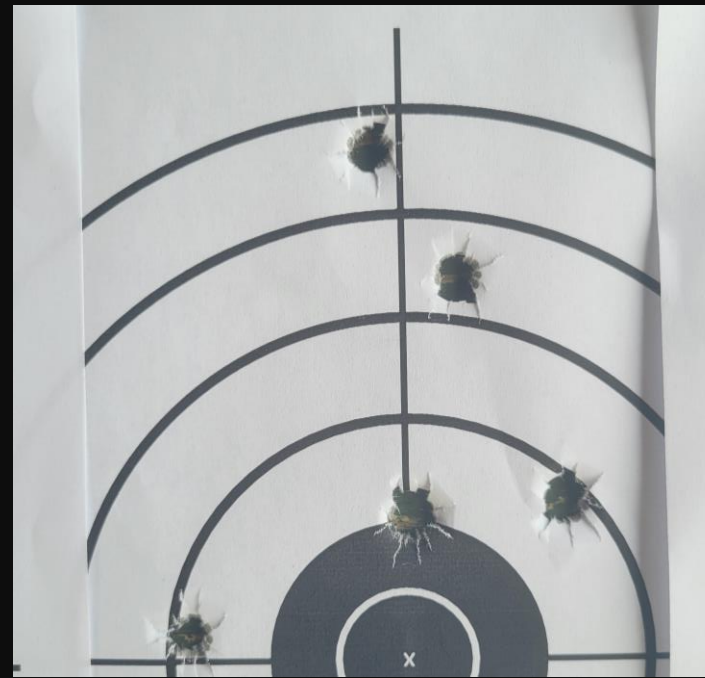
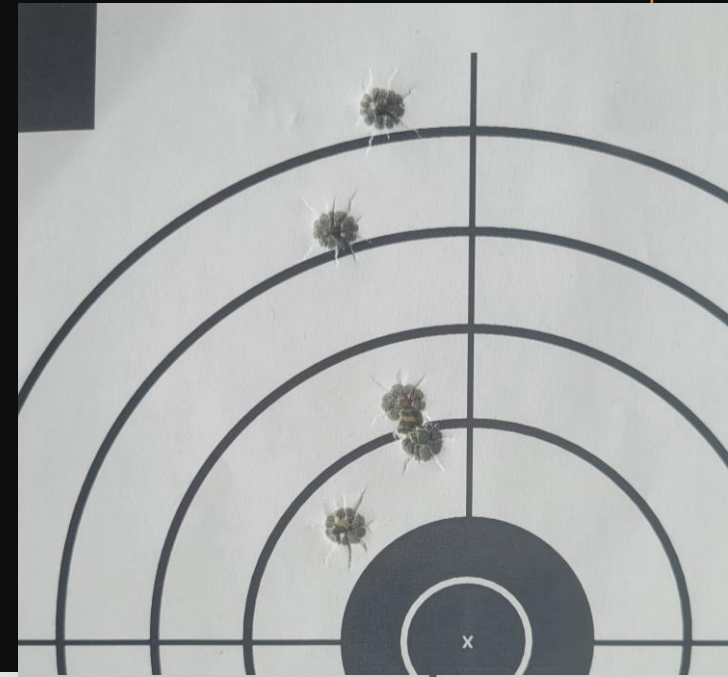
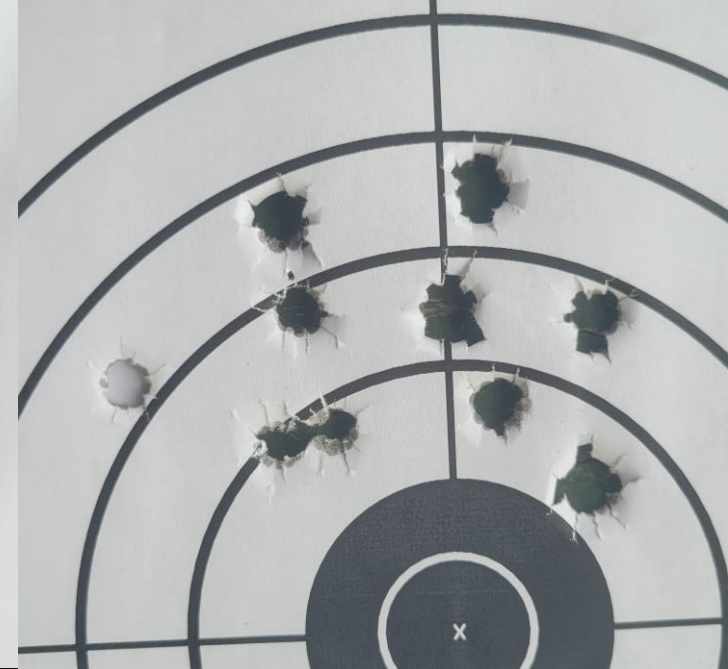
Chinese
Surplus
Groups

- 1970s surplus Chinese 123g FMJ achieved the following group sizes
 - 5rd group – 2.37moa
 - 5rd group – 2.81moa
 - 10rd group – 2.25moa
- New production PPU 124gr SP ammo achieved the following group sizes
 - 5rd group – 1.37moa
 - 5rd group – 2.26moa
 - 10rd group – 3.3moa

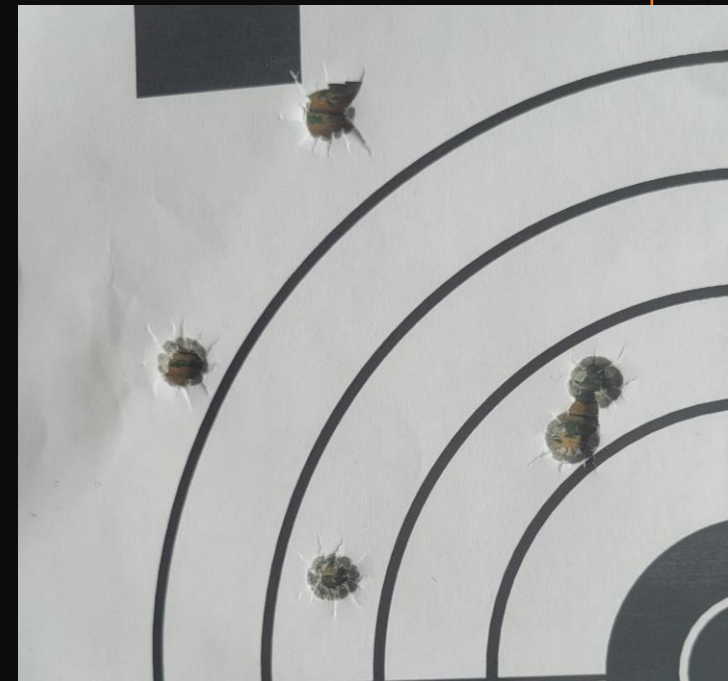
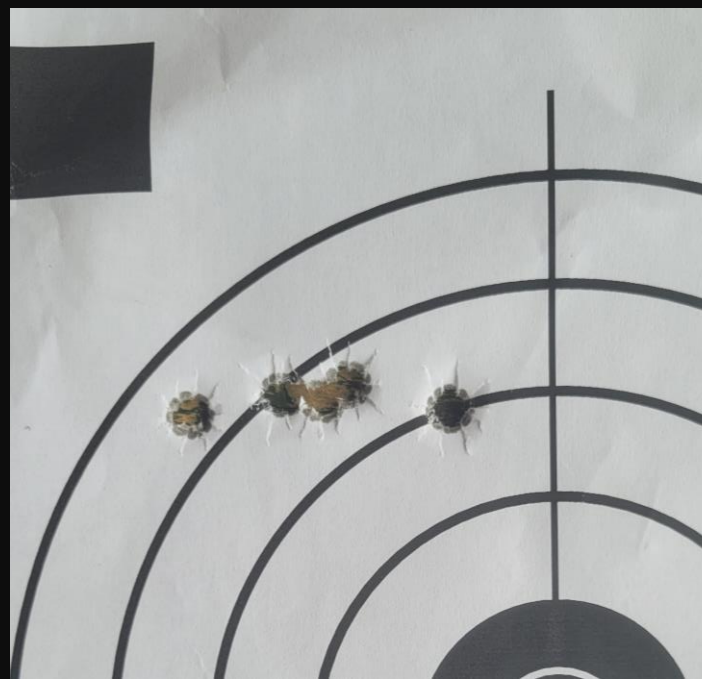
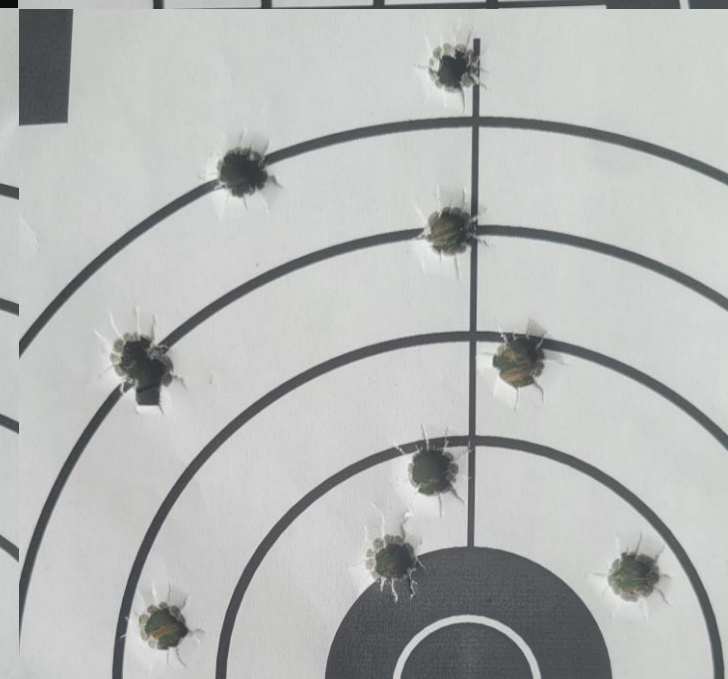
PPU Groups

- 1970s surplus Chinese 123g FMJ achieved the following group sizes
 - 5rd group – 2.37moa
 - 5rd group – 2.81moa
 - 10rd group – 2.25moa
- New production PPU 124gr SP ammo achieved the following group sizes
 - 5rd group – 1.37moa
 - 5rd group – 2.26moa
 - 10rd group – 3.3moa

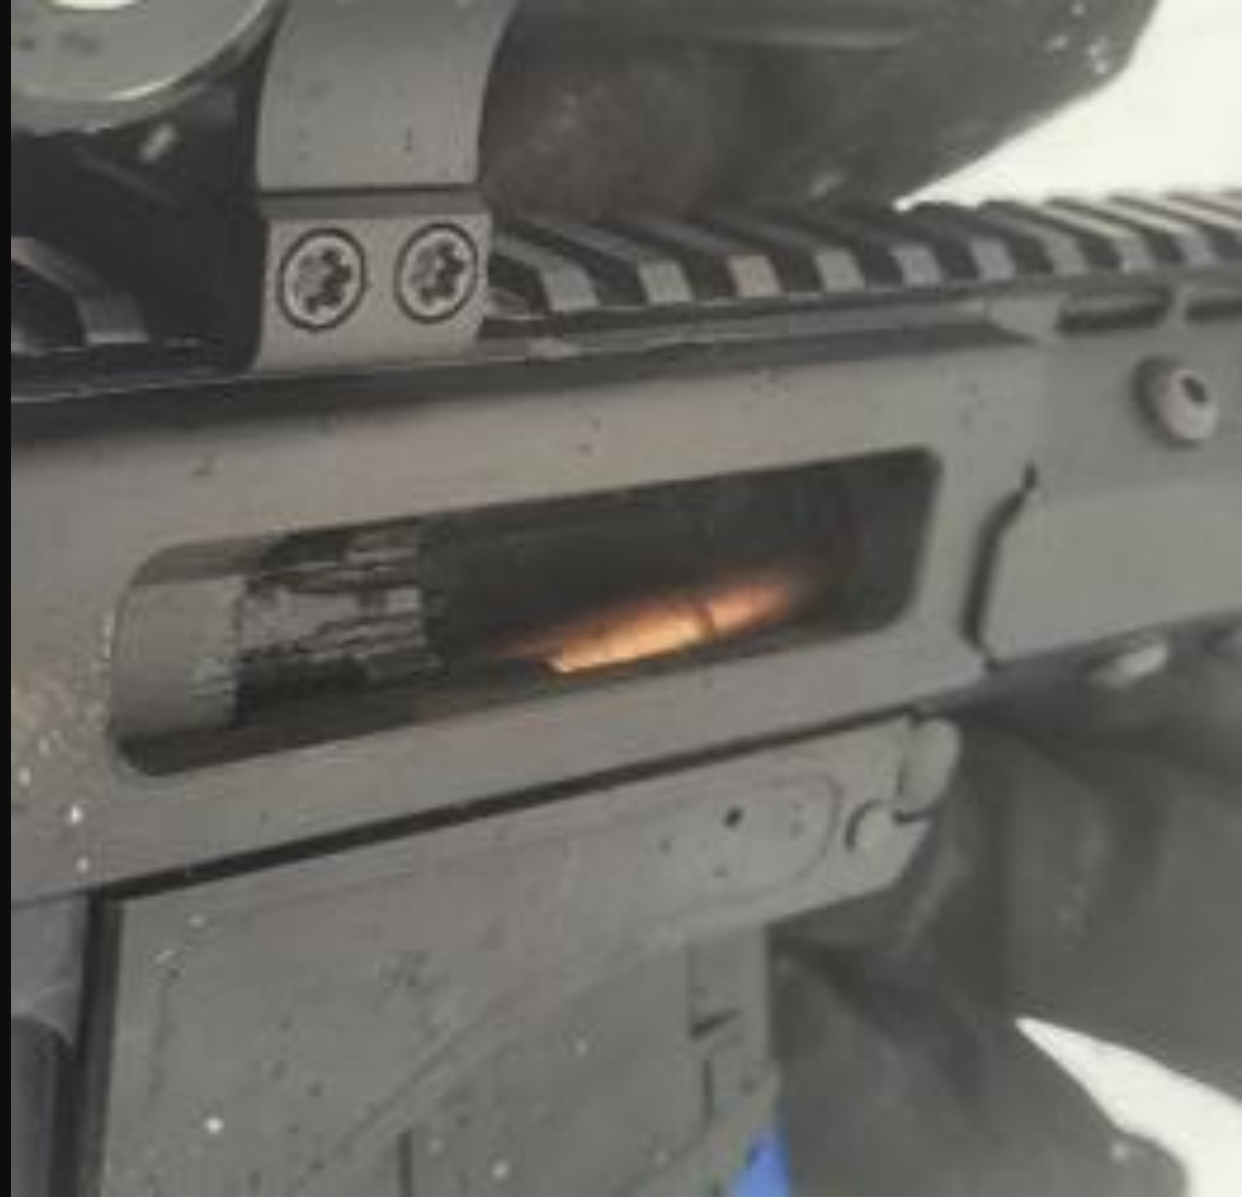
Reliability – Failure to feeds / go into battery

The most common cause of the failure to feed / go into battery is believed to be the weak springs

While 27 are recorded the nature of shooting under pressure, time constraints etc. means that many were remediated through manually actuating the action a second time and went un-recorded as unlike a failure to eject or double feed the resolution is very quick.

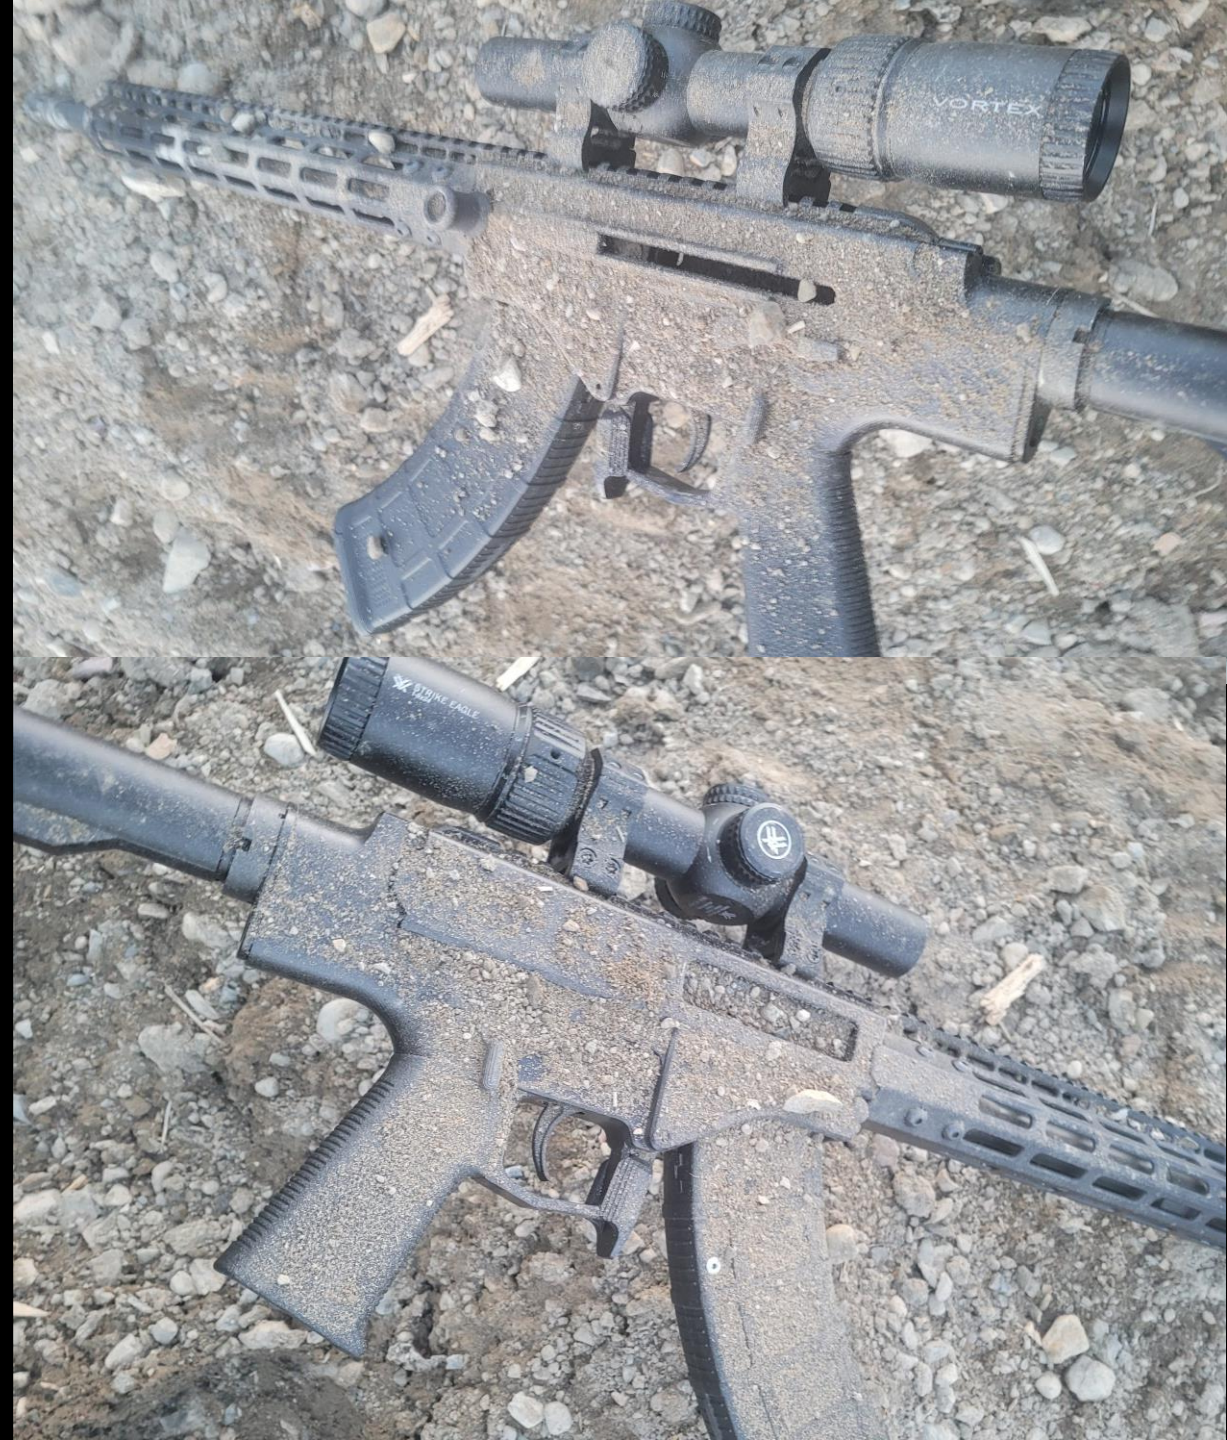
However many dynamic sports shooters and many hunters are likely to place their firearm in the dirt, through brush and more.

A basic dust test was conducted by dropping one handful of dry dirt onto each side of the rifle which was loaded and made ready with Chinese surplus ammo. It was then lifted and given one shake.

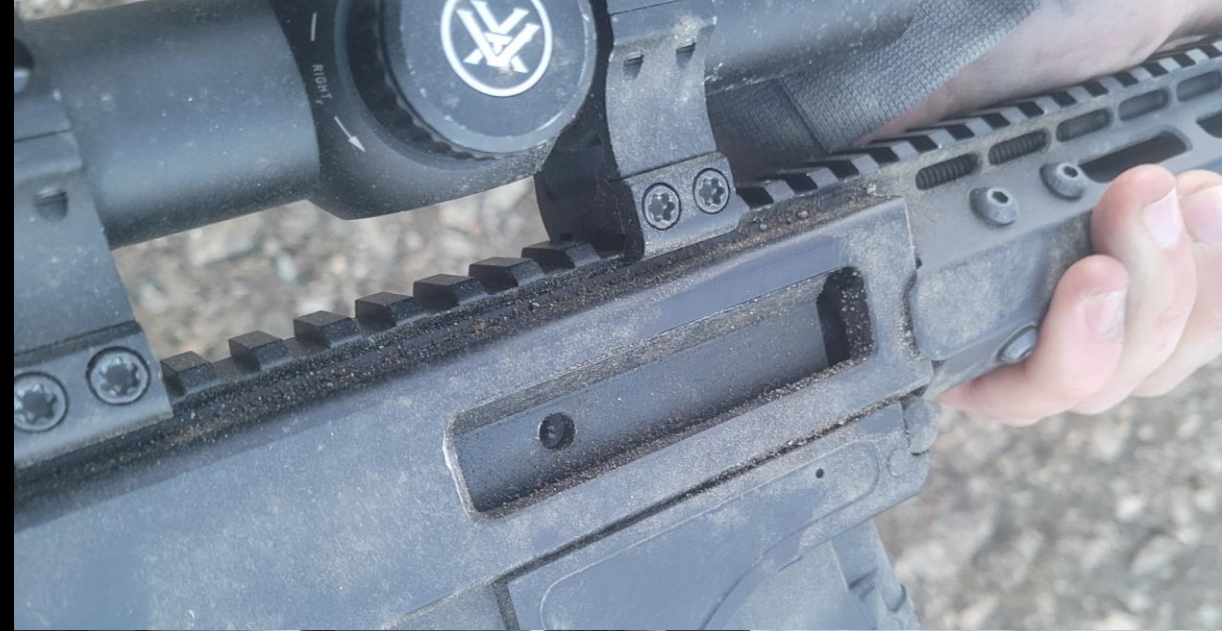
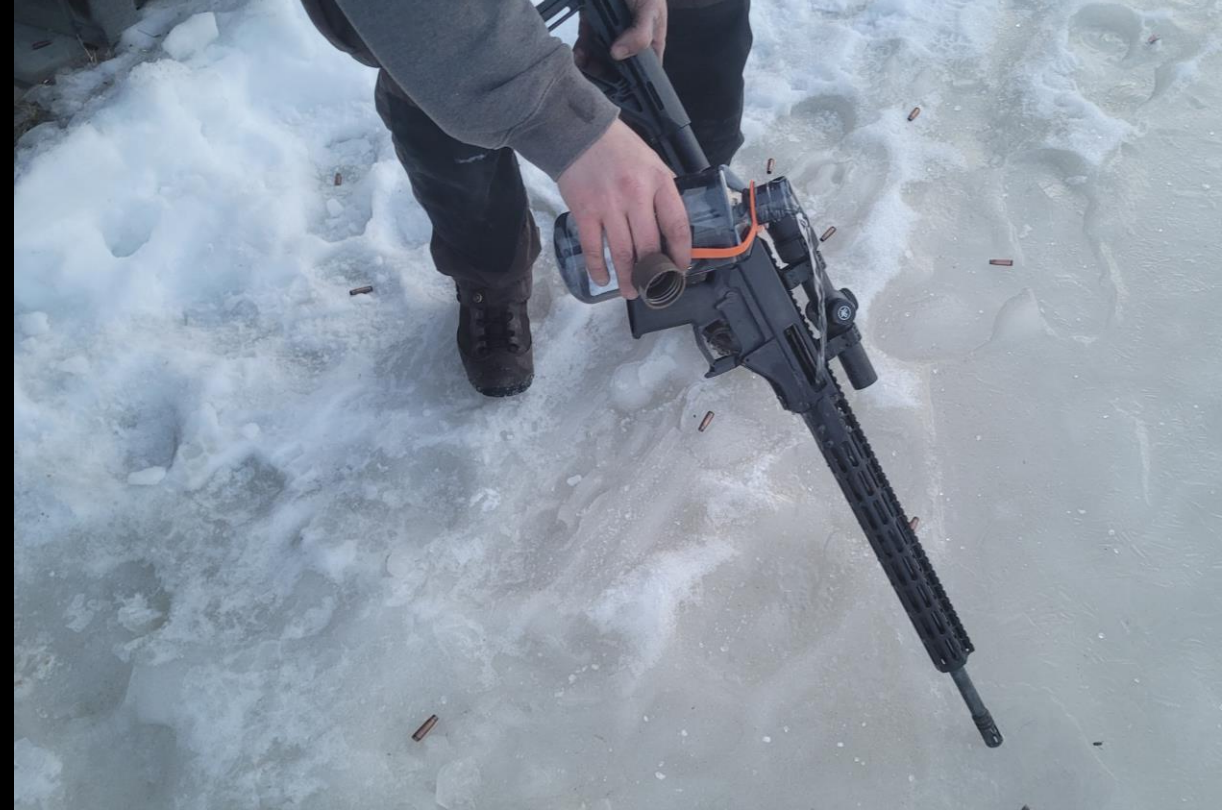
Reliability – Dirt Test (2)

The rifle fired 4 rounds before failing to go into battery

A litre of water was used to clear the action and internal working parts

The firearm did not continue functioning

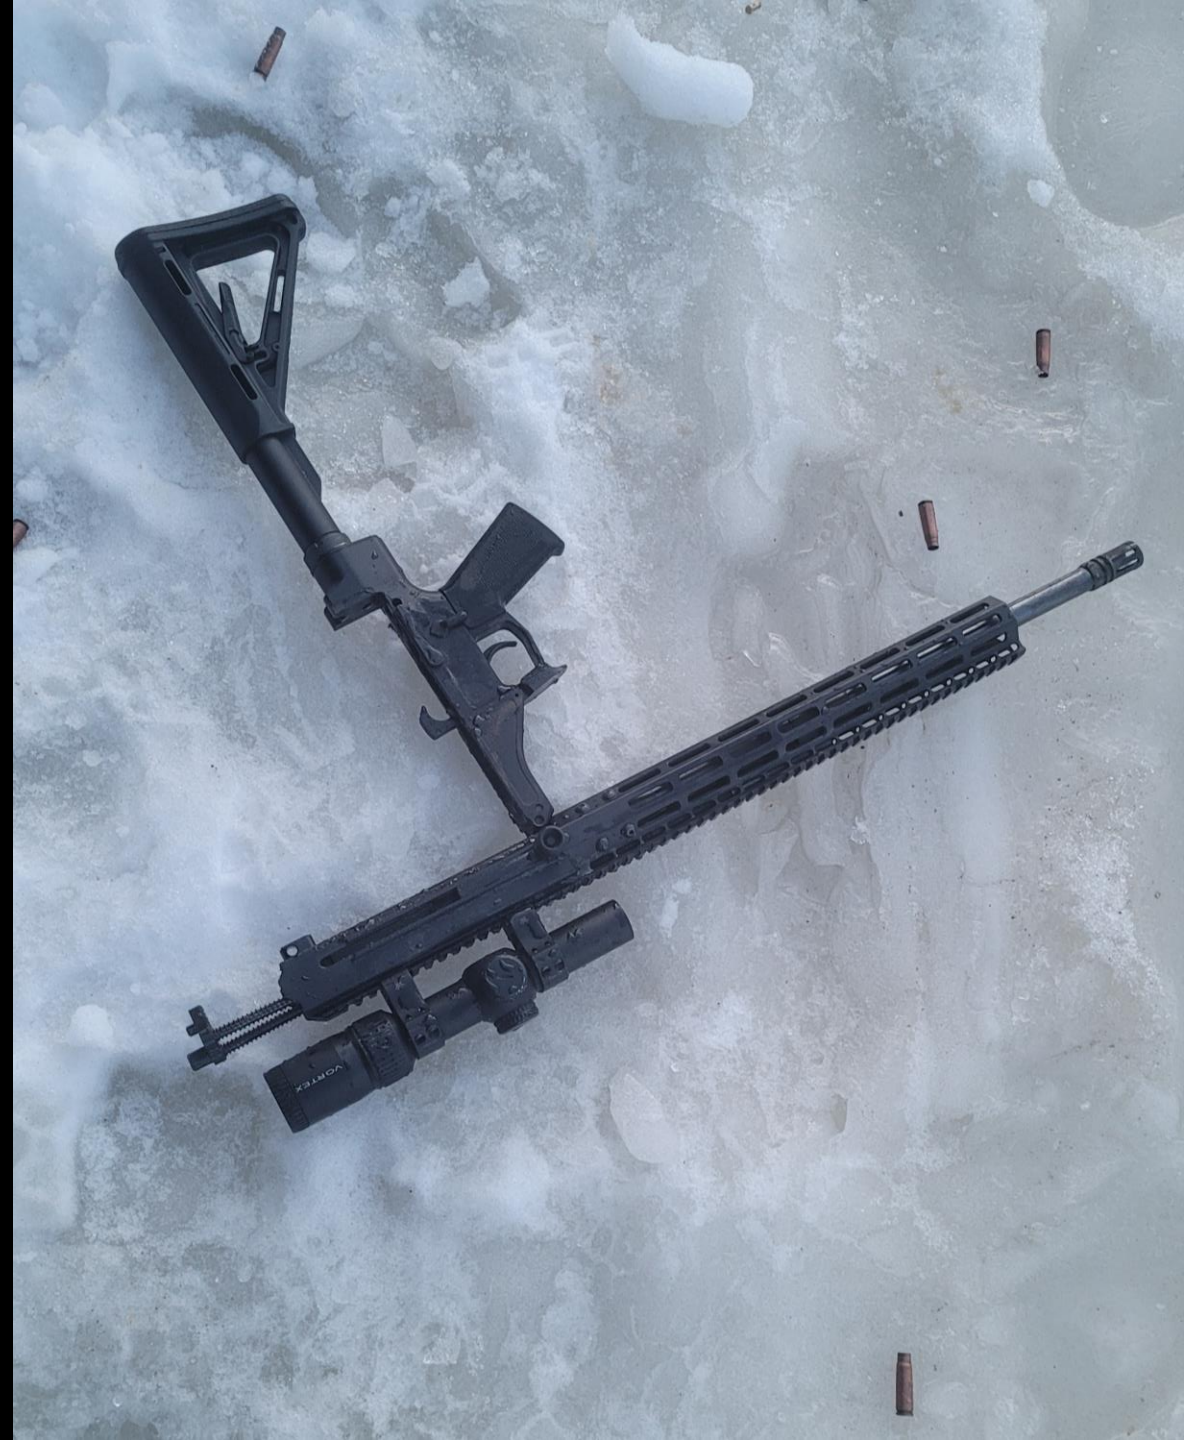
Reliability – Dirt Test (3)

The test did not reveal anything unexpected, however:

- The WS-MCR & R18 Mk2 utilise a bolt the shape which much better seals the action when in battery
- The BCL Siberian & R18 Mk2 utilise cocking handles that fully seal the action

Why has Kodiak not replicated this when going from the WK180 Gen 1 to Gen 2 and then when changing the gas system & bolt carrier for the WK181?

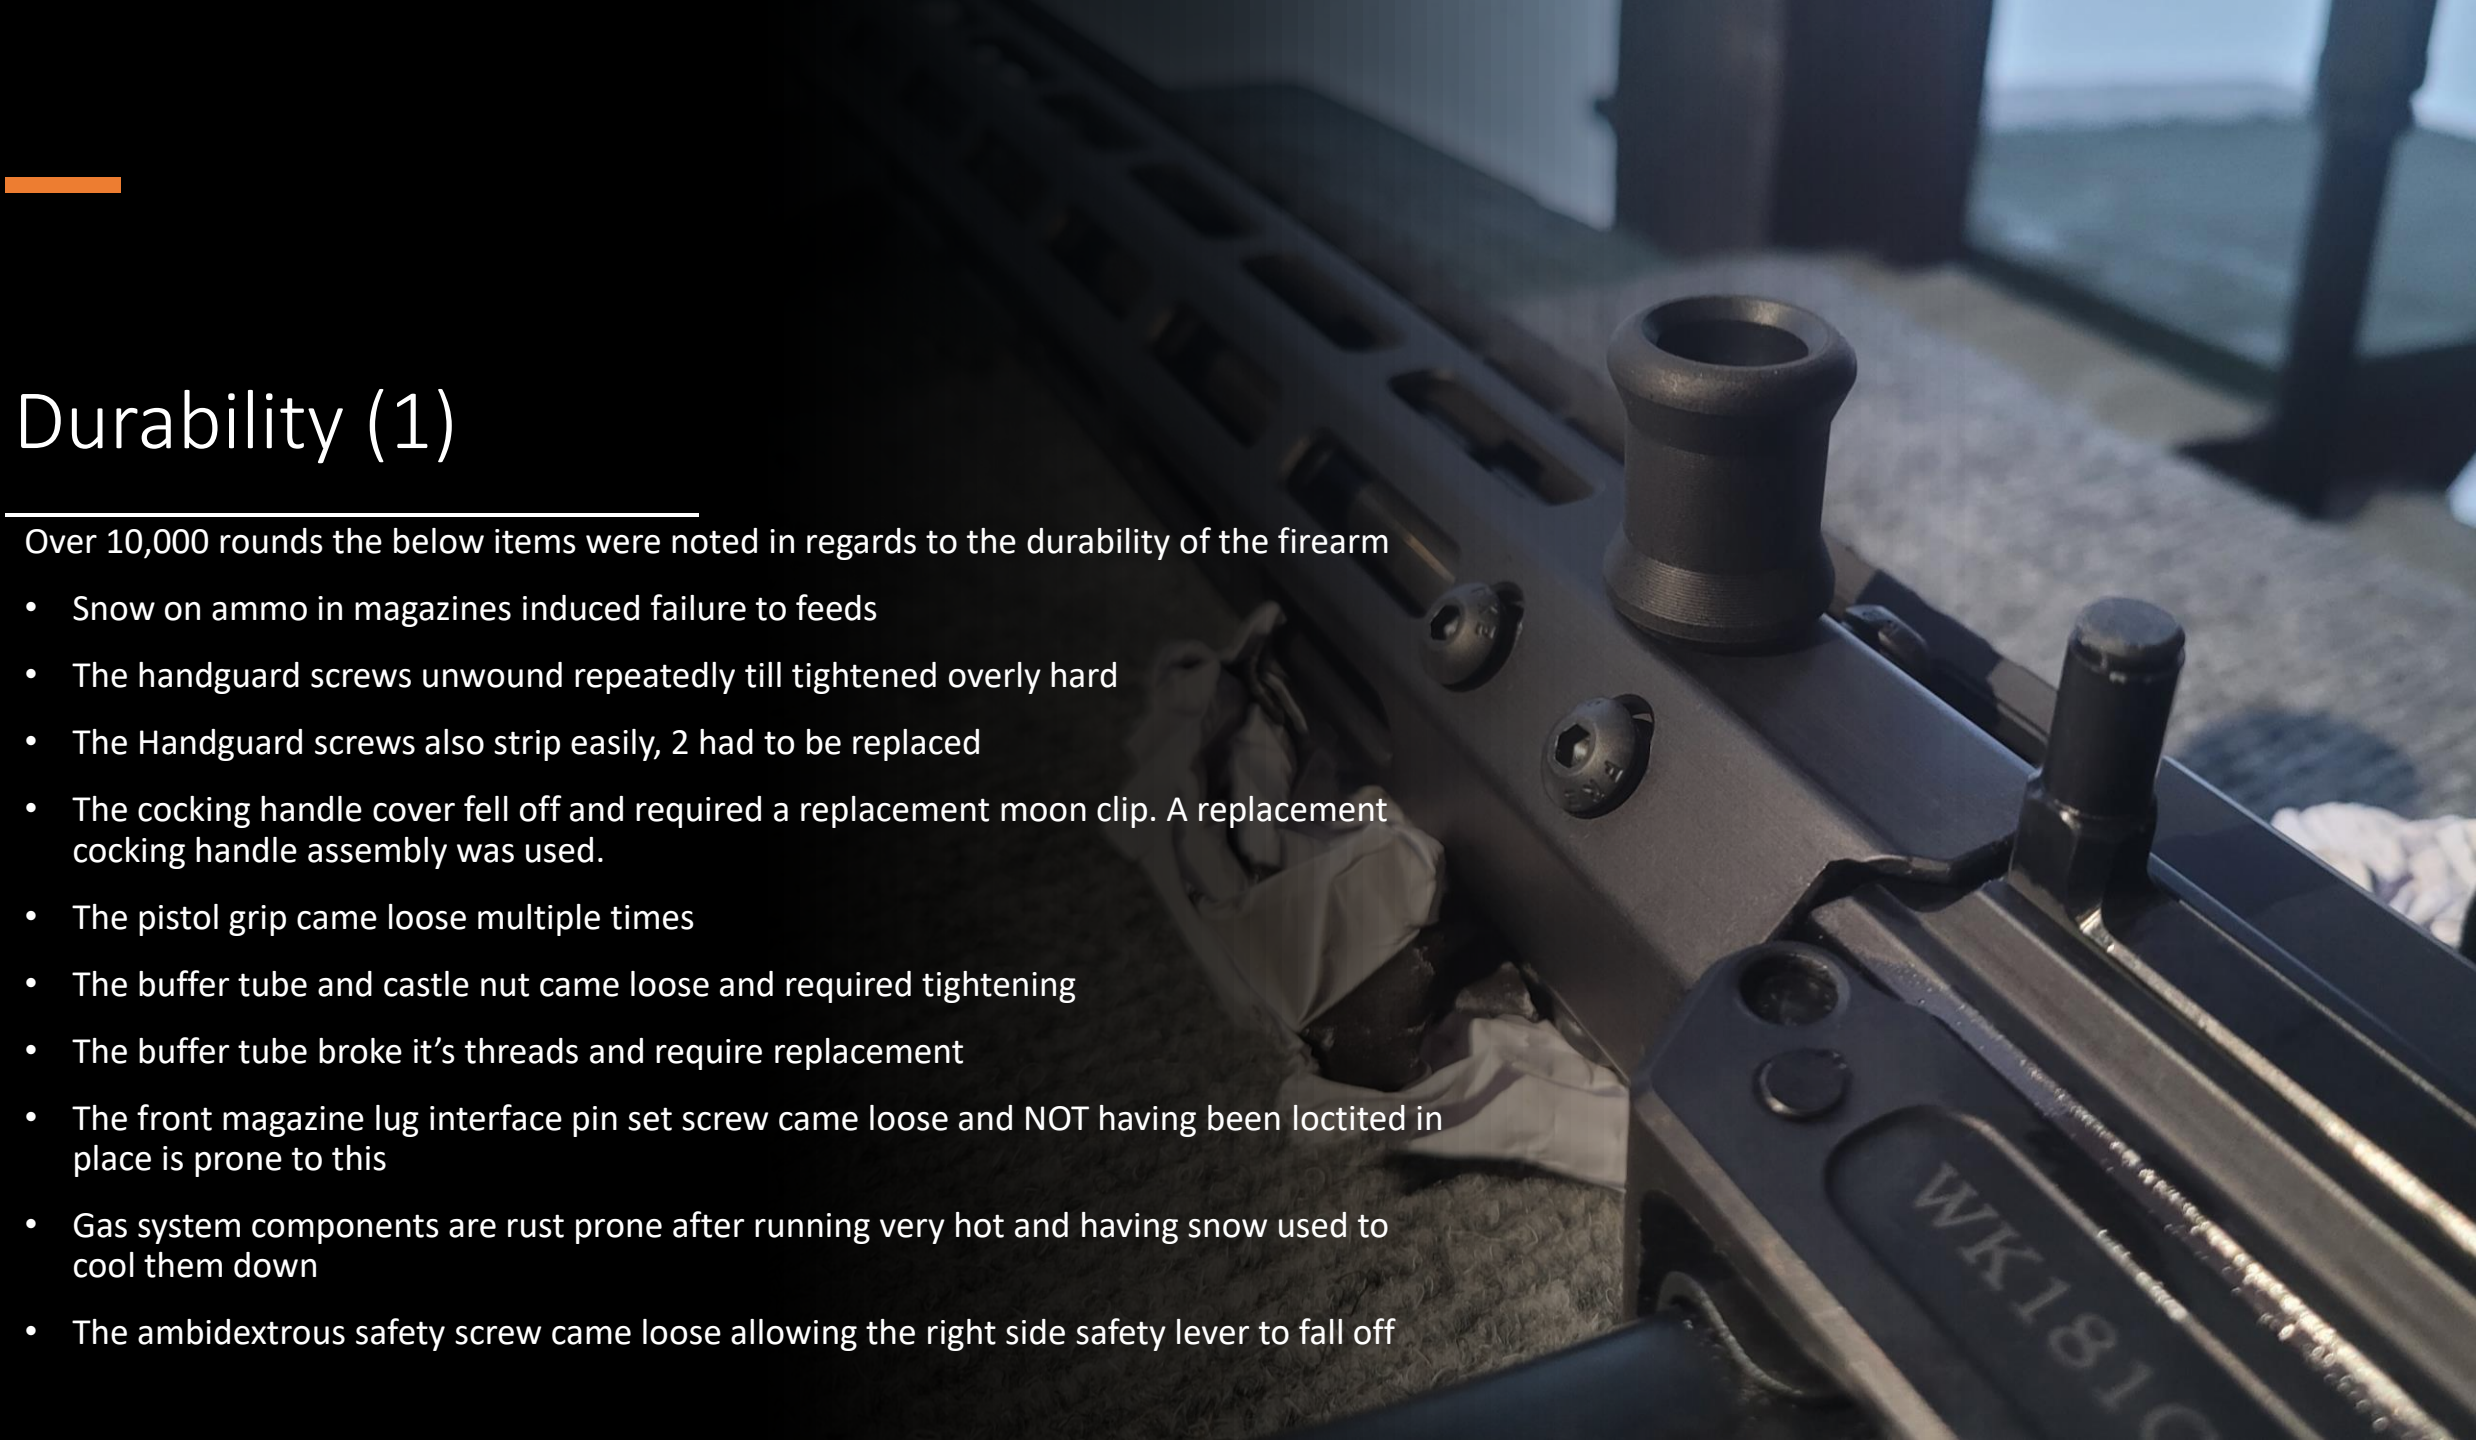
Durability (1)

Over 10,000 rounds the below items were noted in regards to the durability of the firearm

- Snow on ammo in magazines induced failure to feeds
- The handguard screws unwound repeatedly till tightened overly hard
- The Handguard screws also strip easily, 2 had to be replaced
- The cocking handle cover fell off and required a replacement moon clip. A replacement cocking handle assembly was used.
- The pistol grip came loose multiple times
- The buffer tube and castle nut came loose and required tightening
- The buffer tube broke it's threads and require replacement
- The front magazine lug interface pin set screw came loose and NOT having been loctited in place is prone to this
- Gas system components are rust prone after running very hot and having snow used to cool them down
- The ambidextrous safety screw came loose allowing the right side safety lever to fall off

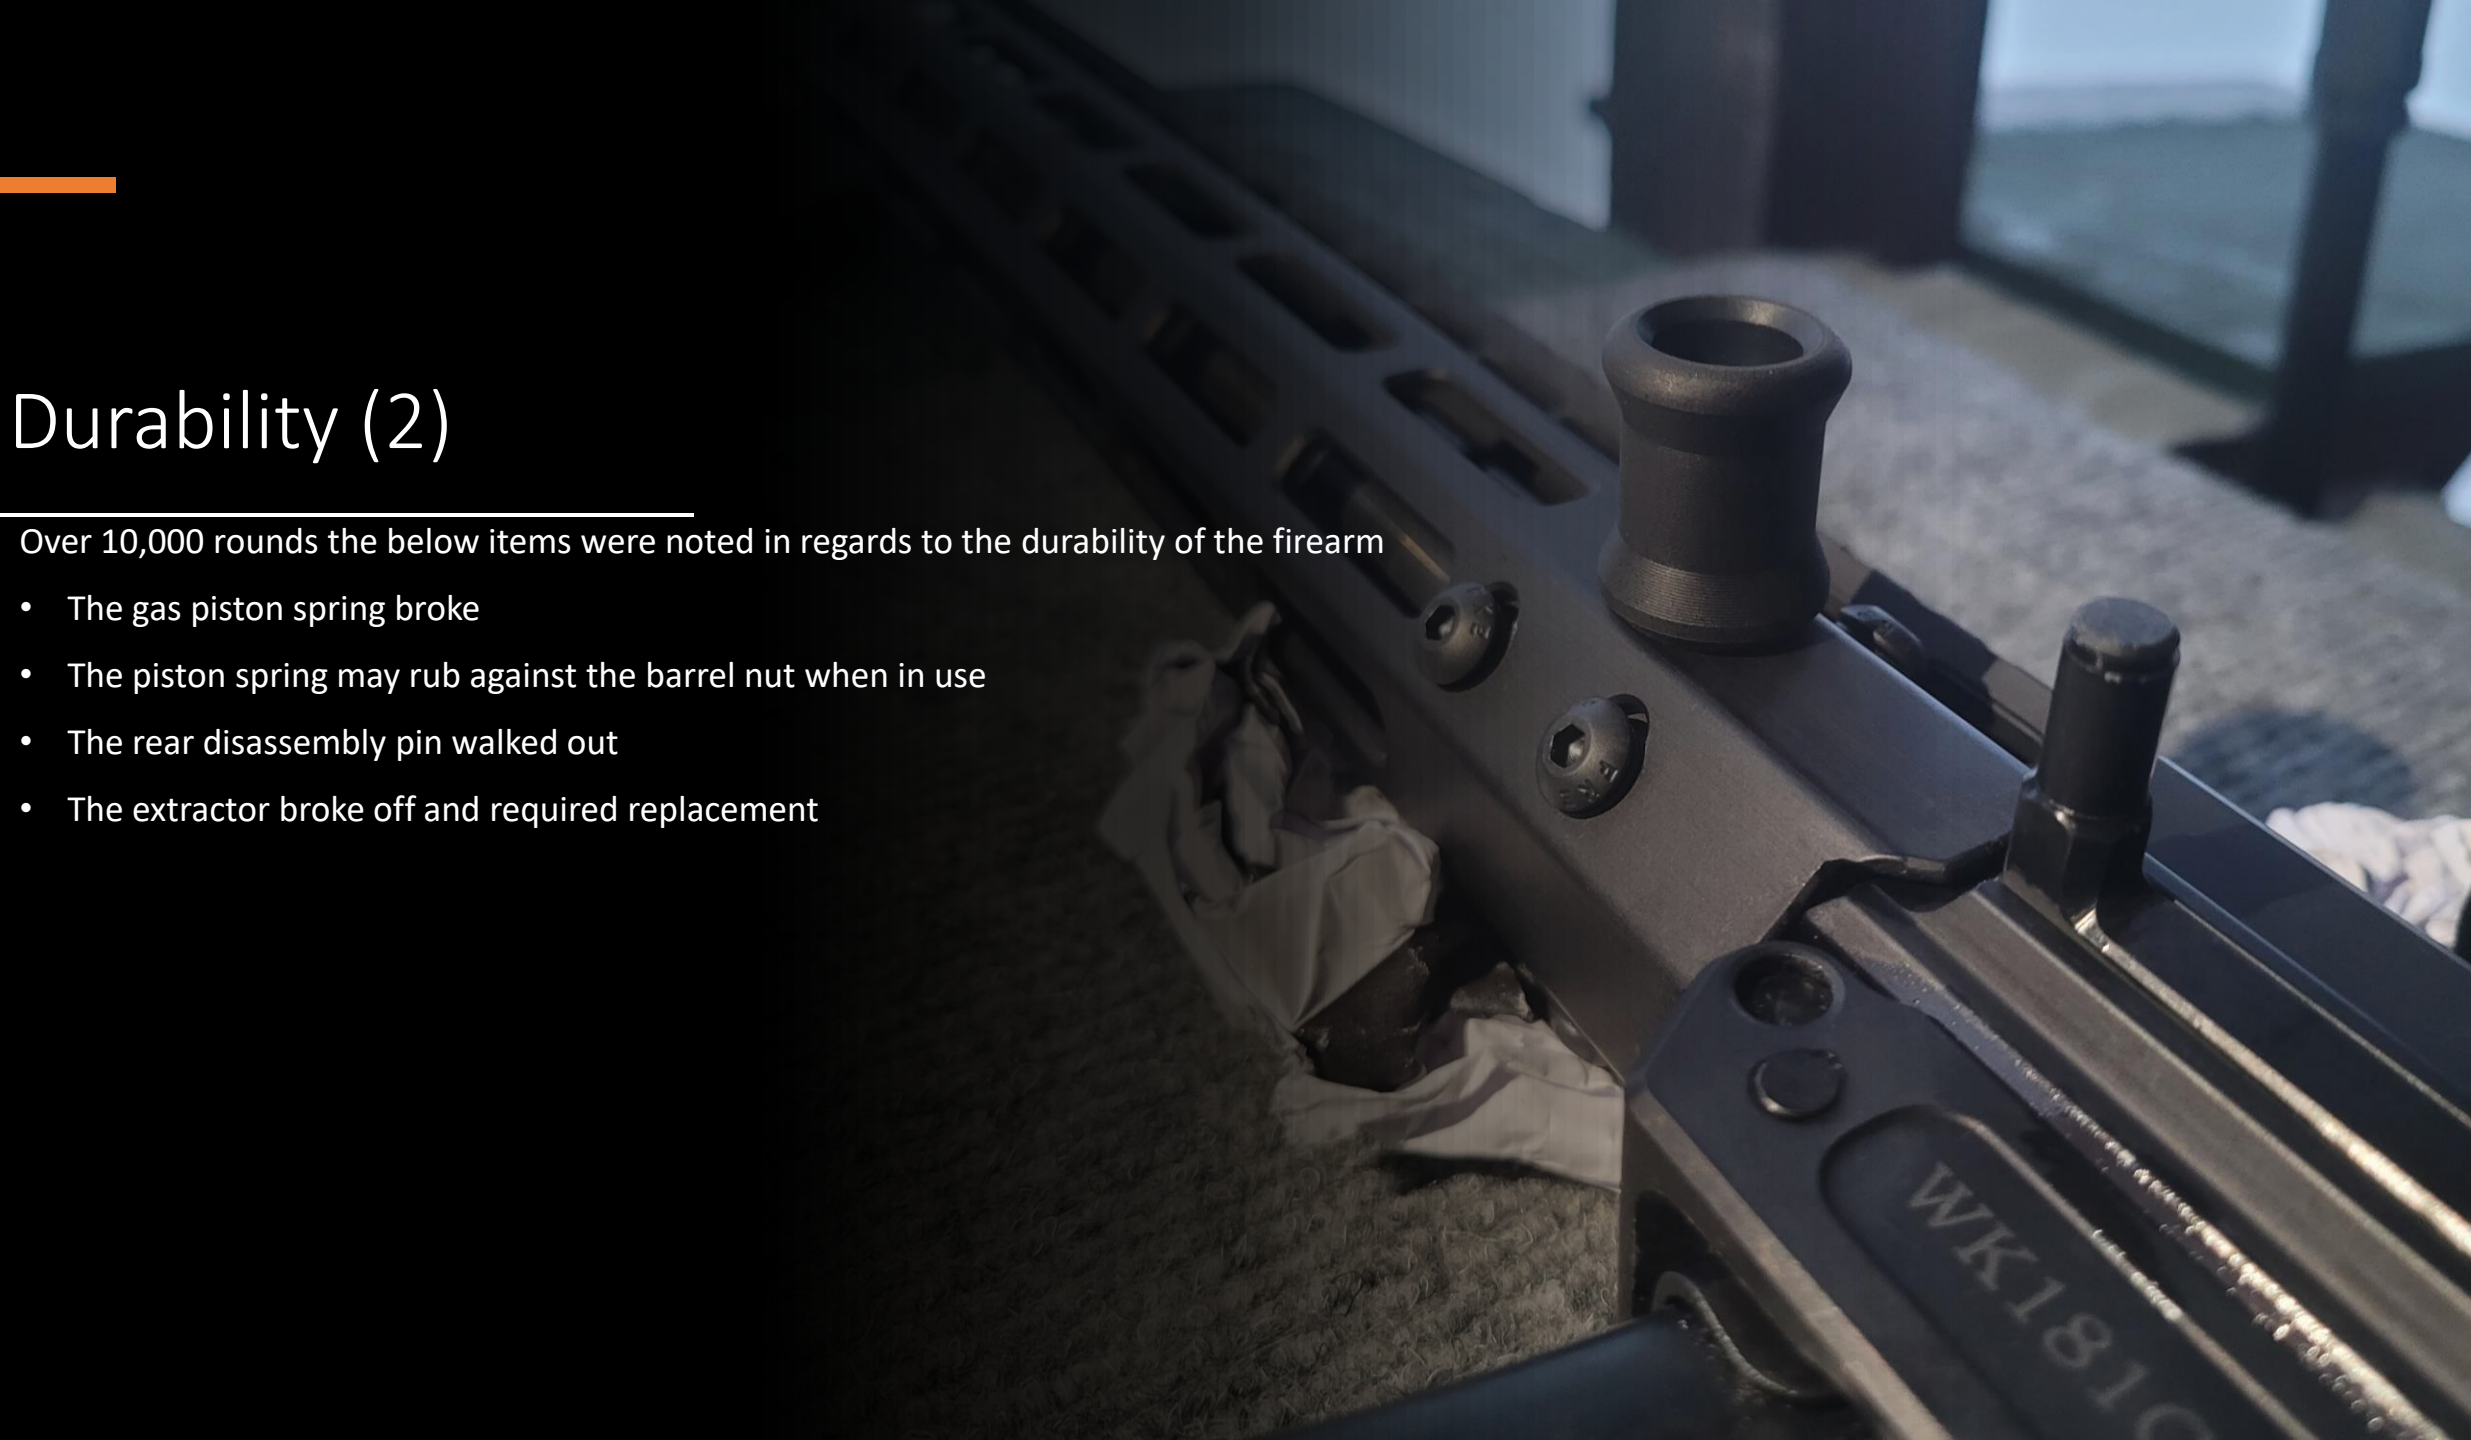
Durability (2)

Over 10,000 rounds the below items were noted in regards to the durability of the firearm

- The gas piston spring broke
- The piston spring may rub against the barrel nut when in use
- The rear disassembly pin walked out
- The extractor broke off and required replacement

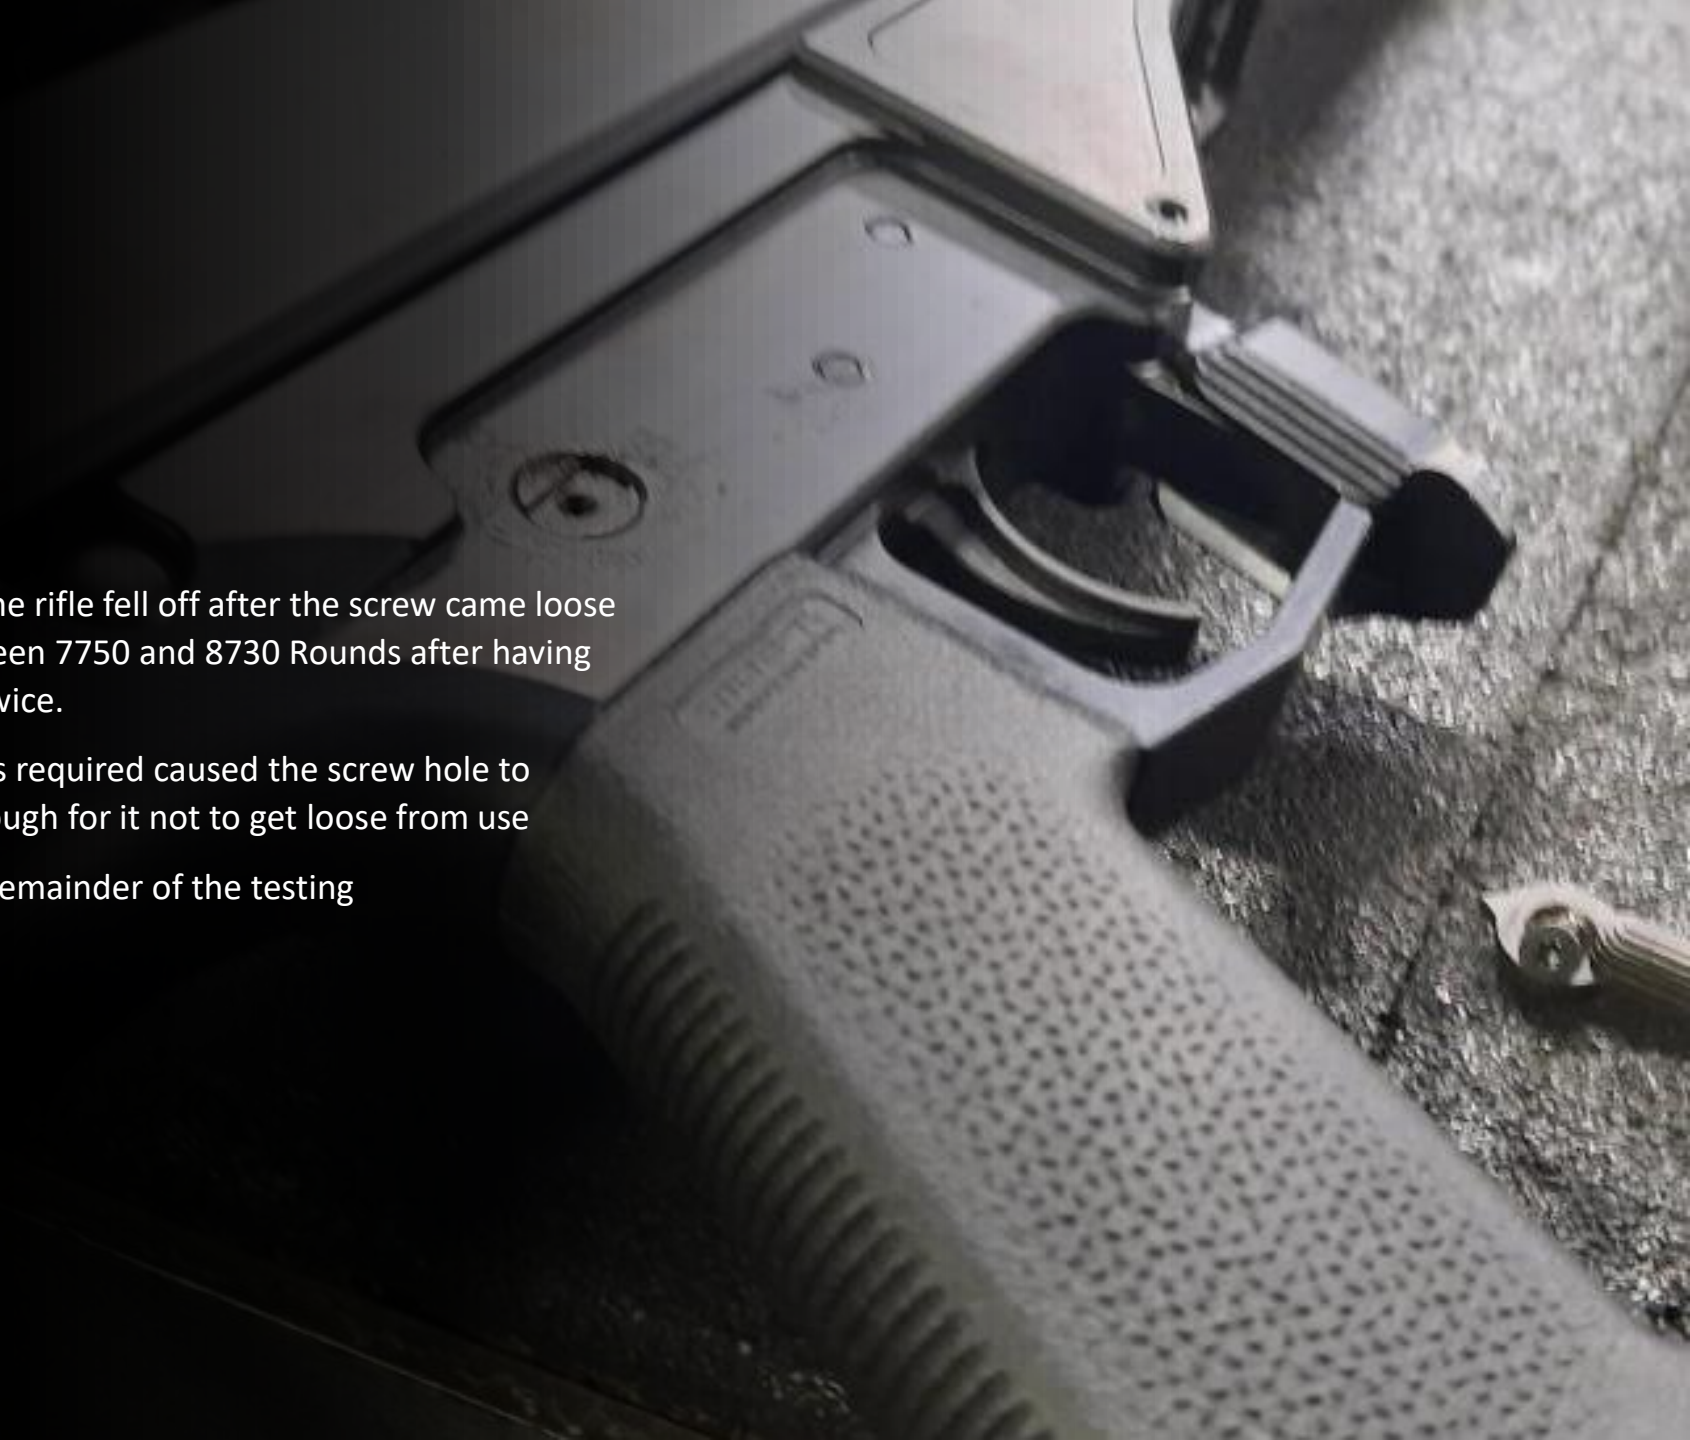
At 7750 rounds the safety lever on the right side of the rifle fell off after the screw came loose and fell out but was re-attached without issue. Between 7750 and 8730 Rounds after having previously being tightened the safety fell out again twice.

On inspection it was found that torquing the screw as required caused the screw hole to deform, making it harder to screw it back in tight enough for it not to get loose from use

The safety remained detached from the rifle for the remainder of the testing
