WK181 10K Endurance Test Full Review

A Canadian Firearms Endurance
Testing Report

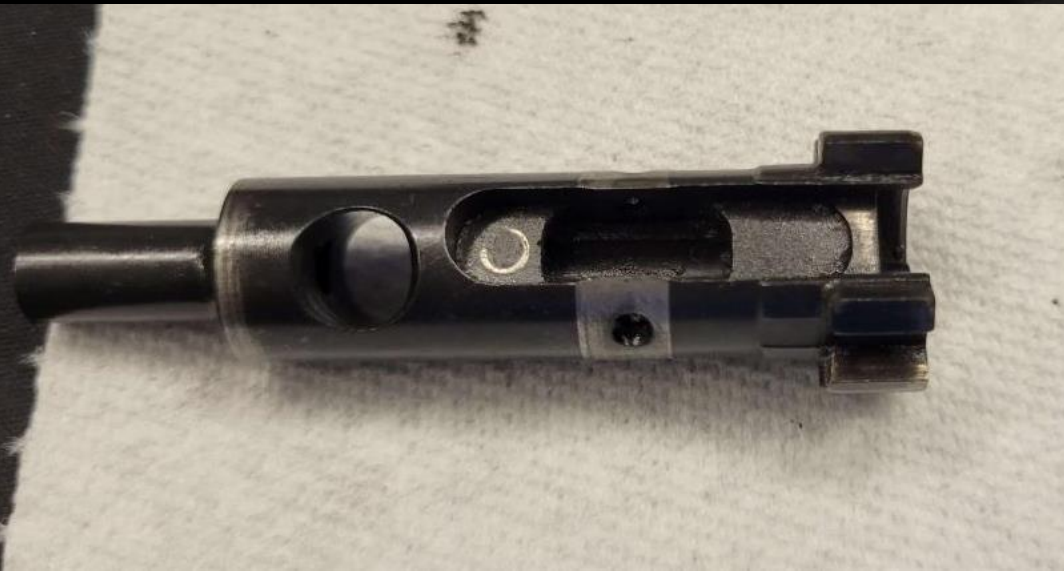
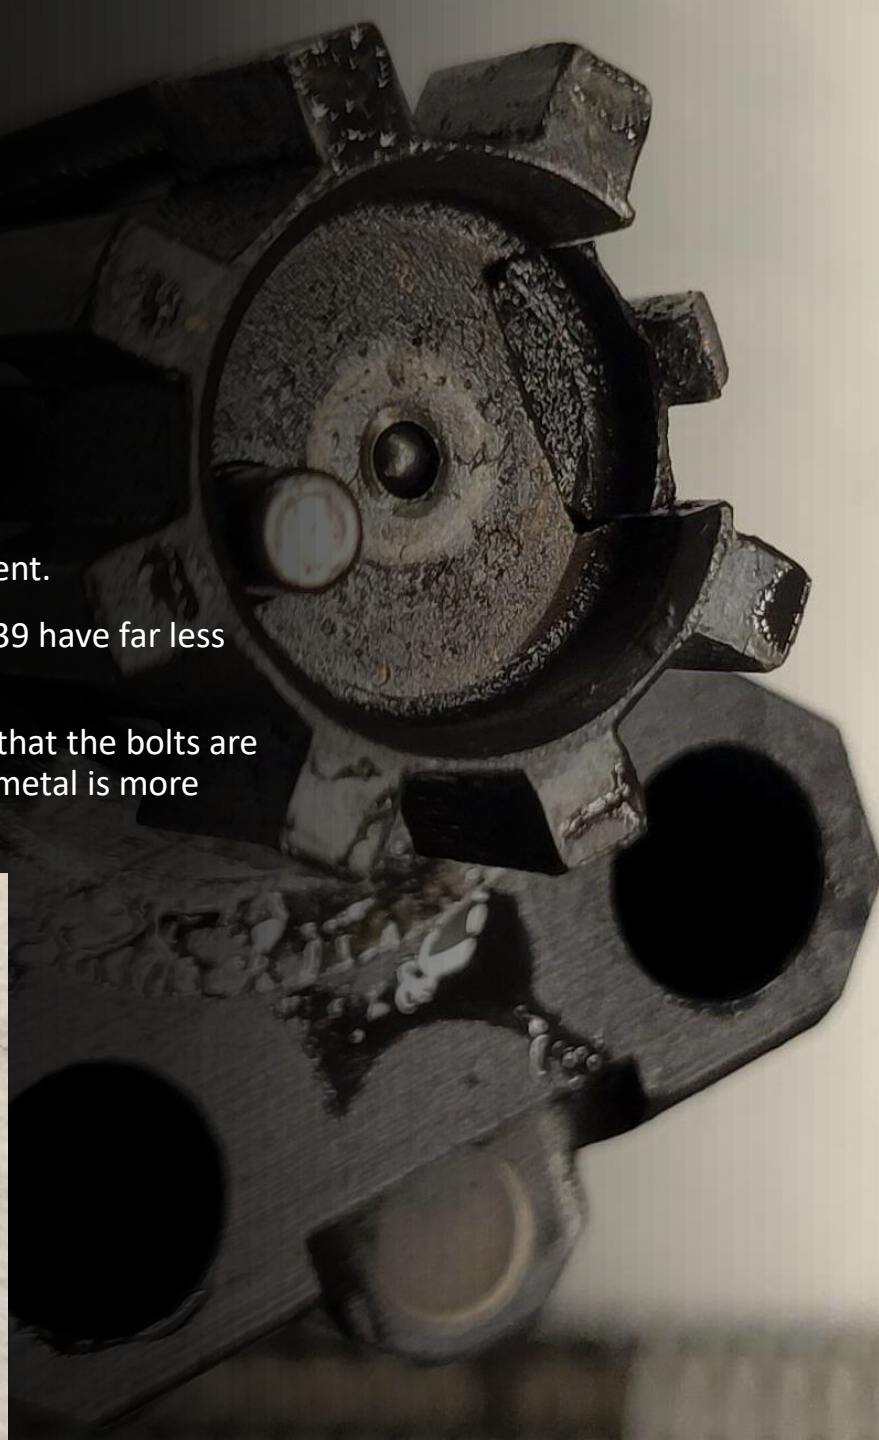
At 8731 rounds the extractor broke off entirely and required replacement.

Bolts that are originally designed around 5.56x45 when used for 7.62x39 have far less material at the rim as can be seen

Those who intend to use firearms utilising such bolts should be aware that the bolts are more frequent to breakage, especially during cold weather where the metal is more brittle

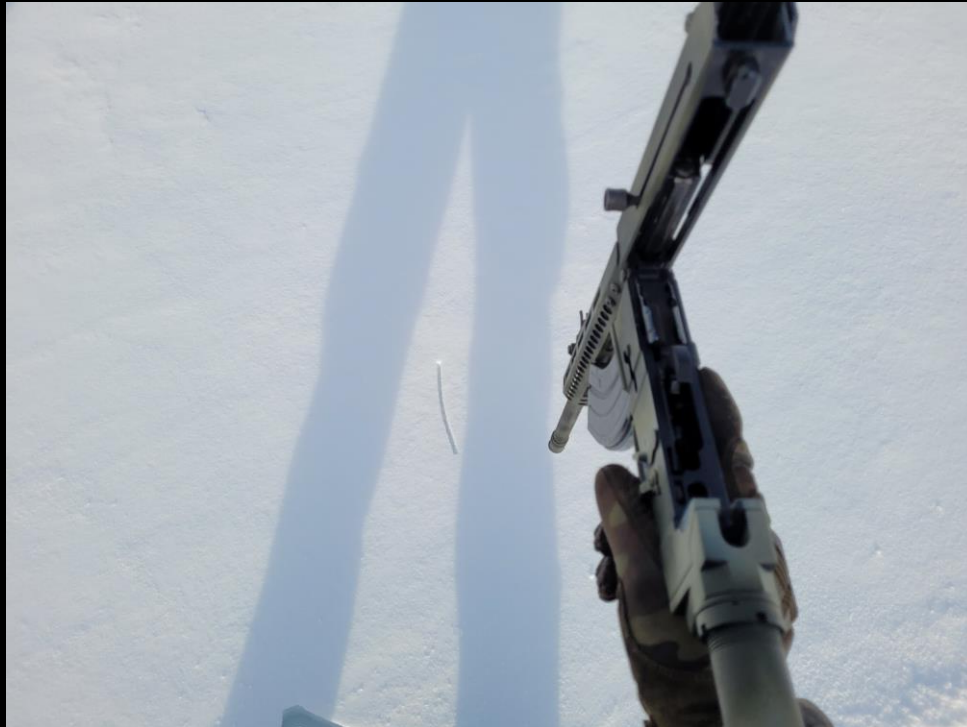
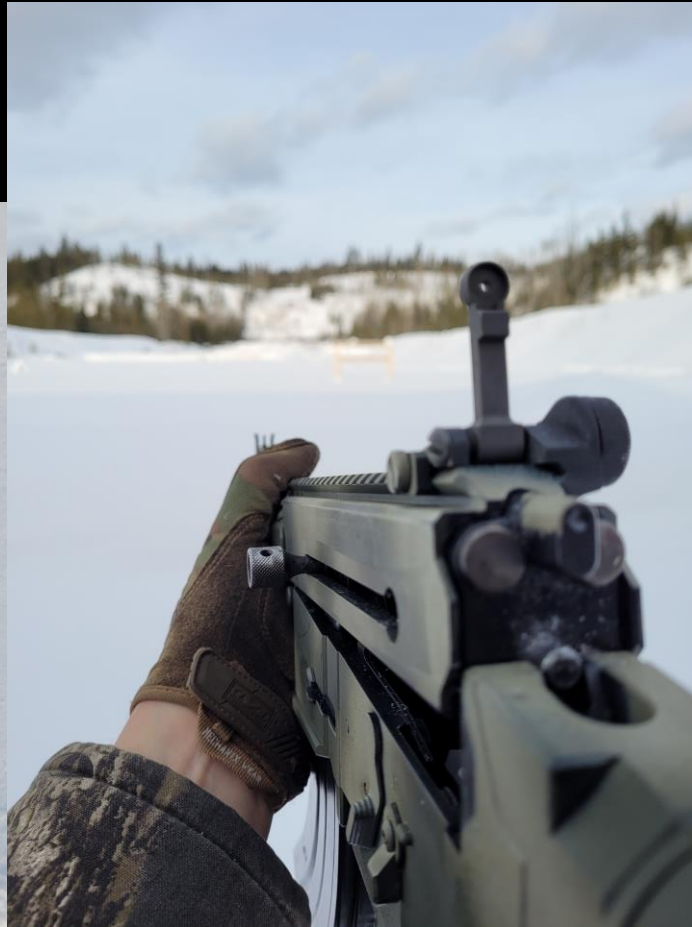
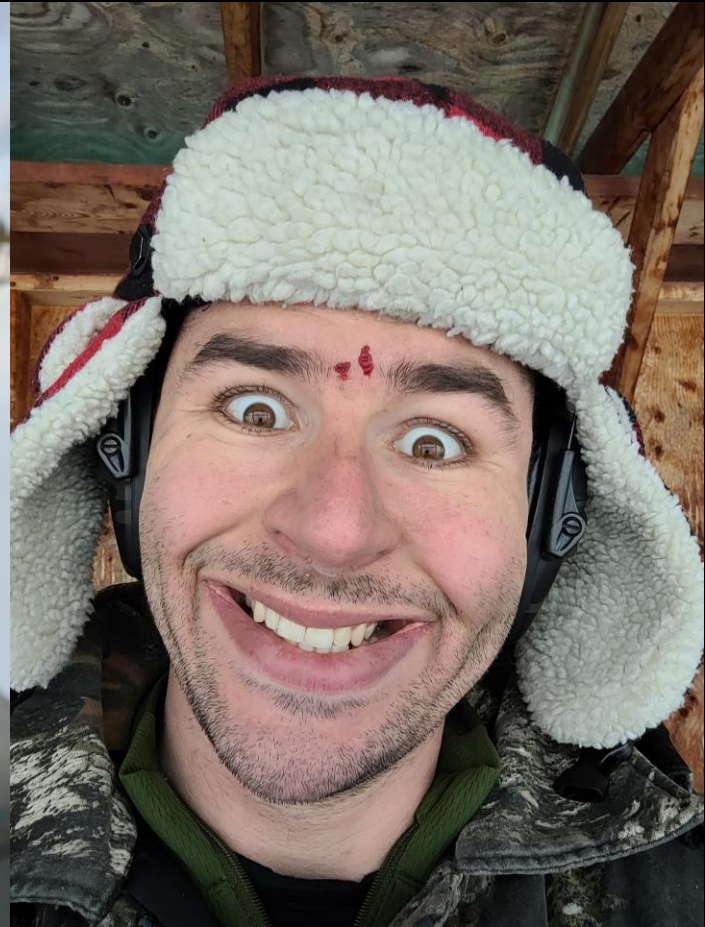
The Spring Issue (2)

The outcome of the self disassembly is as pictured, at the start it just popped open a little, then it was picking pieces out of the snow and then wiping blood off your face

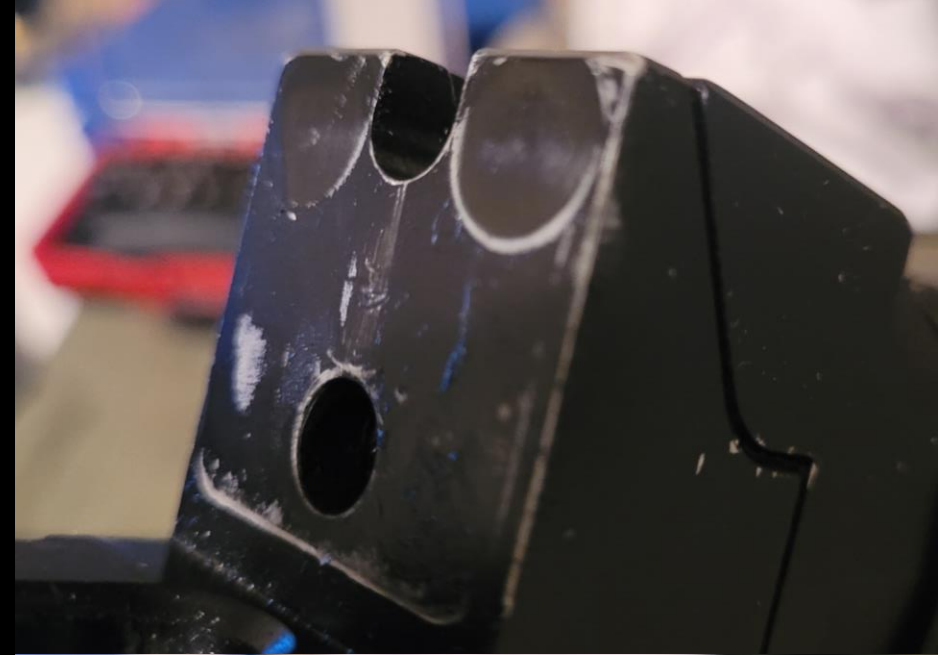
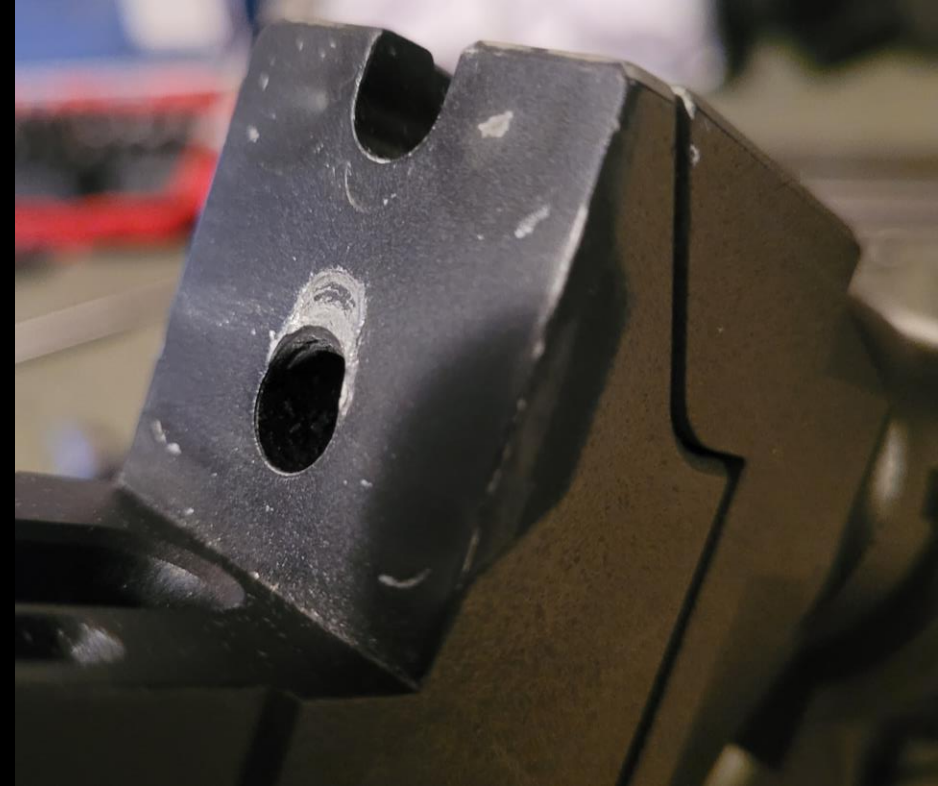
The Spring Issue (3)

Pictured is a WK180 Gen 1 Lower with 14,000 rounds of 5.56 usage (top) and the 7.62x39 lower with circa 2000 rounds usage. The tester sent the below summary of thoughts to Kodiak Defence Jan 2022. Please note: The author of this section is not an engineer nor a firearms specialist, these thoughts are those of a non-expert

“Where the bread slice mates with the receiver the 5.56 it is in exactly the same condition as new. But on the 7.62 it has been elongated and become more oval shaped.”

I believe the WK180 762 is beating itself to death. I think that by using the same gas & recoil springs system + BCG as in 5.56 the BCG is being thrown rearward with much more force than 5.56. When the BCG hits the breadslice and moves forwards the breadslice then bounces forwards out of it's slot. It sits on the edge of the interface and the next round causes the BCG to smack against it, steel vs aluminum, steel wins and the hole is gradually elongated.

Based on my experiences so far the recoil assembly is coming out before the BCG fully returns to battery. This poses quite the danger because as the erosion progresses the ease of disassembly likewise increases and thus the time for the BCG to return battery grows shorter.

Maybe, just maybe there is something inherently special about my firearm that has caused this but I have no reason to believe so. Quite the opposite stands true. My concern is that other people's rifles have a similar issue and that someone is going to lose an eye. Its funny when I get a Harry Potter scar but less so when someone starts sharing pictures of their kid's eye damage. Therefore it is my belief that every single 7.62x39 upper or full rifle you have sold will have this issue because there is nothing different about how I used mine. I genuinely believe you need to recall them and I do not say this thinking it is a small issue.”

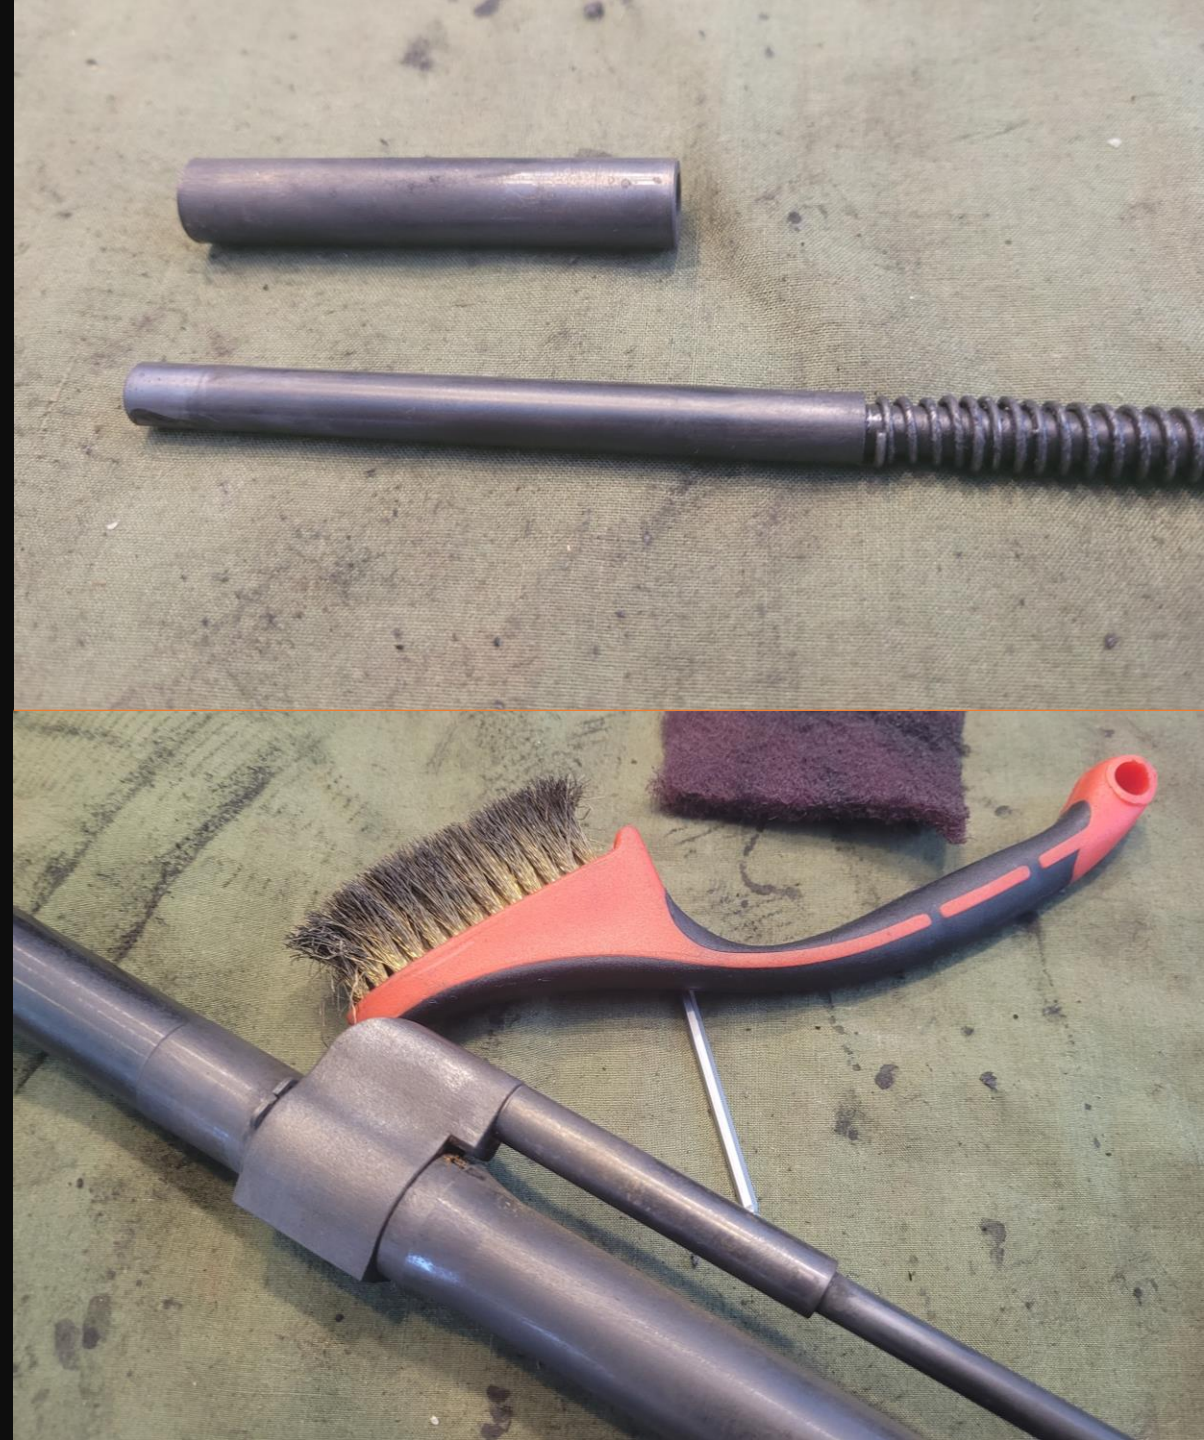
CAF Weapons Technician Report at 10k

- The buffer and butt stock of the receiver had no defects or abnormalities. Rear plate of the receiver has slight grooving. The rear plate of the receiver where the springs and plate rest shows slight grooving of the metal from use

- Safety selector missing right side (Is present but missing screw)
- Overall finish of the lower receiver was still present and in good condition. Most of the wear being found on expected components such as the magazine catch and mag well. The Upper receiver is in fairly good condition for 10K Rounds. Majority of wear located where ejection is impacting the receiver to the point of metal peening. A deflector would be a welcome addition.

- The charging handle groove and other surfaces with metal moving had an expected amount of finish removed
- The bolt bearing surface (behind the locking lugs) had uneven wear of the finish and when inside the bolt was loose fit (wobble) Locking lugs have peening towards the rear of the lugs and the peening is uneven

- The bolt carrier has normal wear from trigger group on the underside of the carrier However large peening from hammer impacts where the firing pin is struck

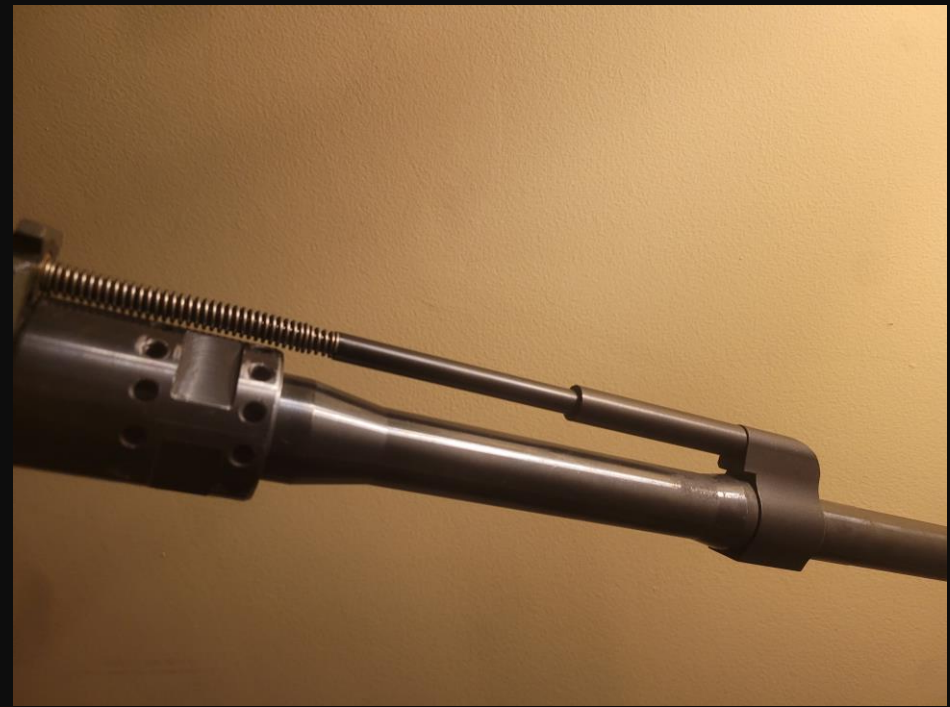
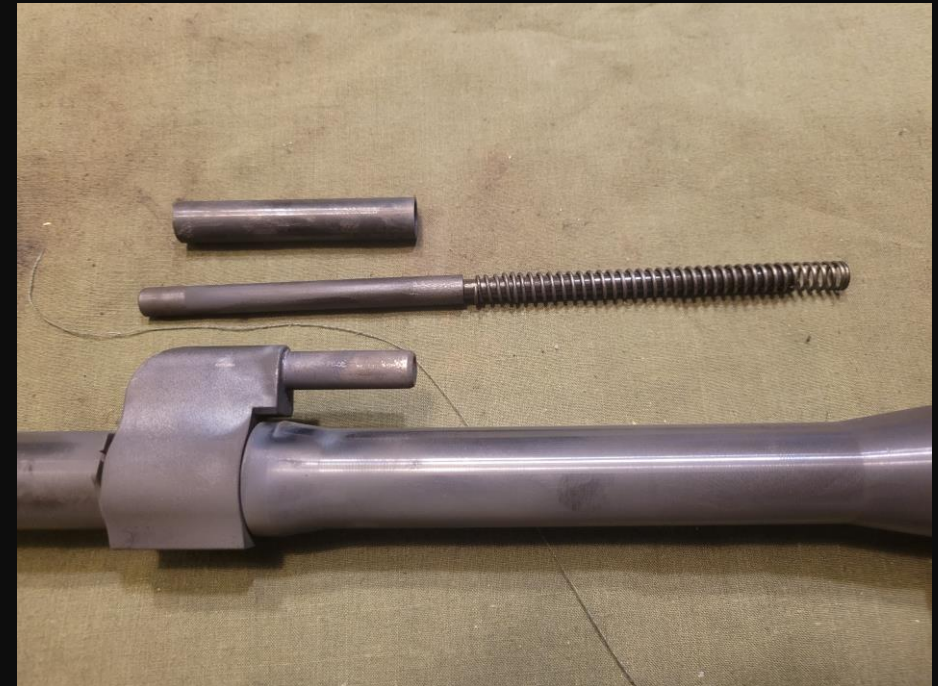
A look at the rifle (3)

The 181 has a different gas system than the 180 gen 1 or 2 it uses a shorter piston rod, an extended gas tube which is shrouded by a gas cup

The lower picture shows the Gas system after 1045 rounds of Chinese surplus and 5 PPU hunting rounds, not bad, much cleaner than the same amount of ammo through a Type 81 or SKS

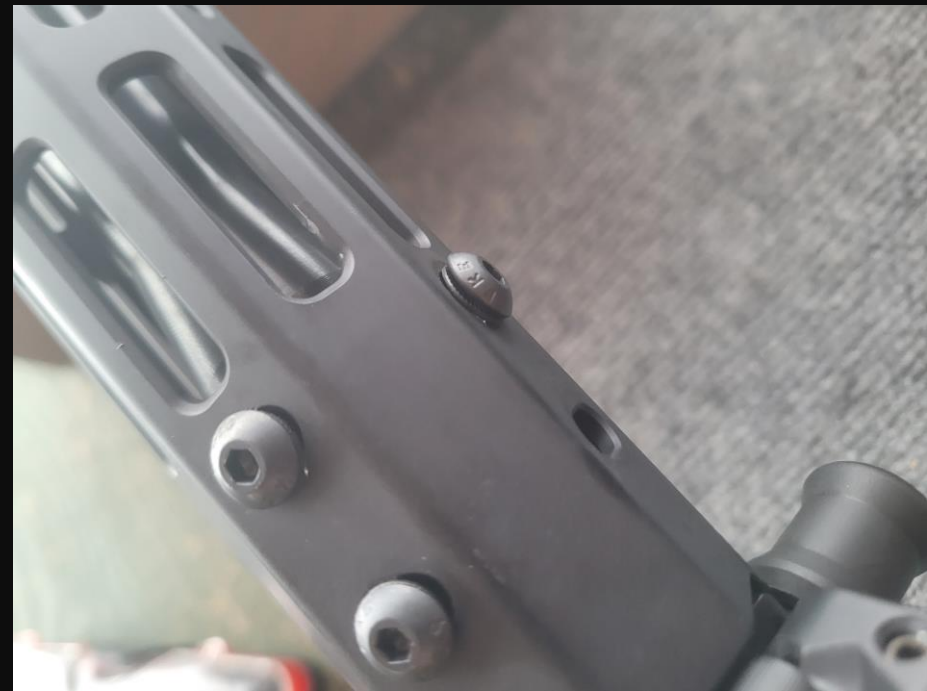
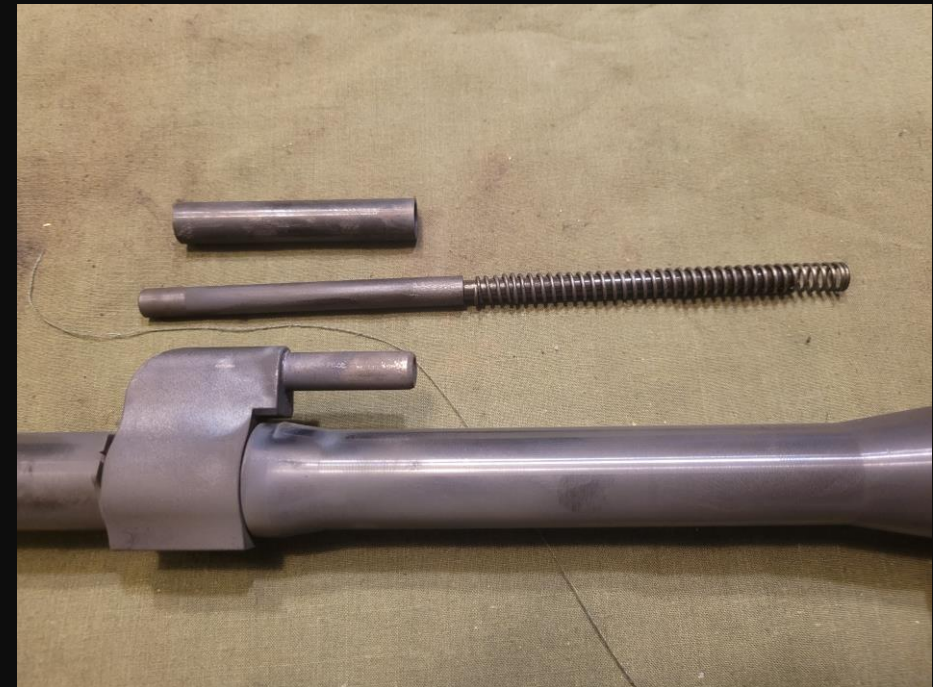
A look at the rifle (4)

The simplicity is good, ease of disassembly is not

The screws easily strip and two had to be replaced in the earlier stages of the test before it was decided to cease removing the handguard as frequently.

The use of Torx screws would reduce this issue and the use of a different handguard with 2-3 screws would be a welcome change

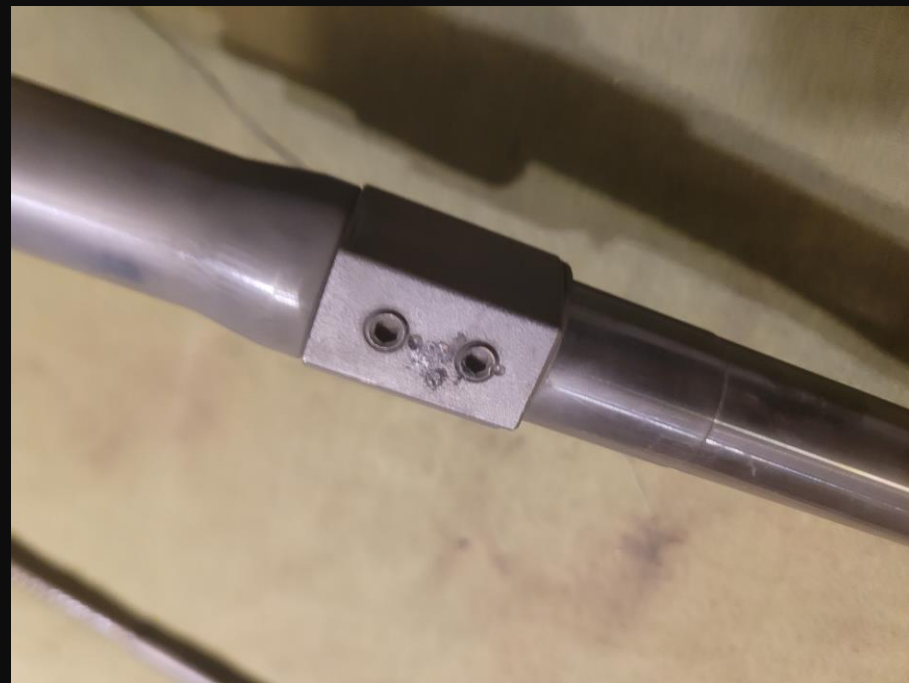
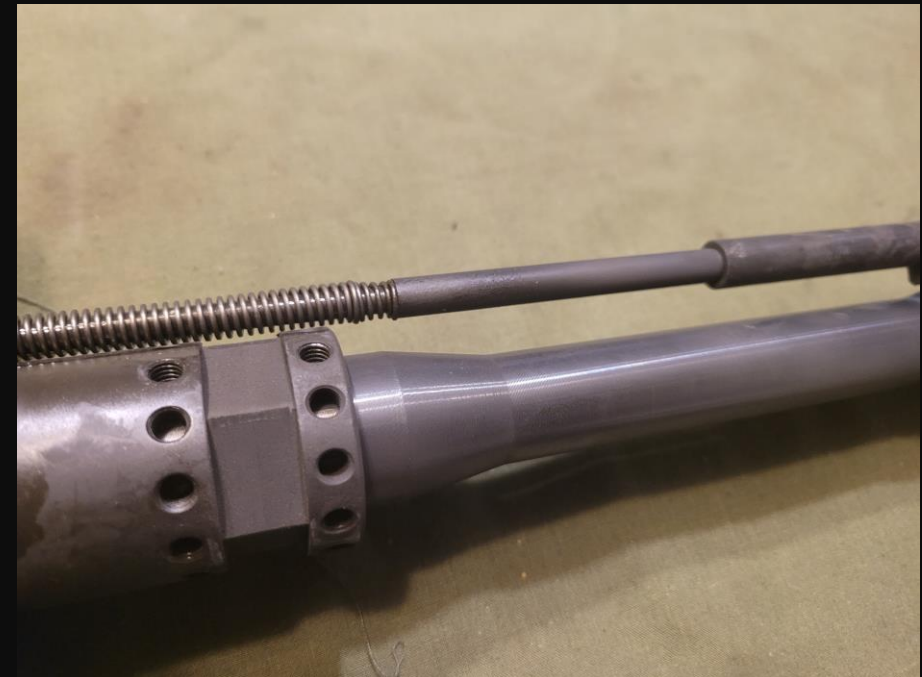
A look at the rifle (5)

It looks like at least one of the gas block screws was staked and an attempt at the second one made but missed

Look how narrow the gap is between the barrel nut and the gas system, this may reduce room to use a thicker piston

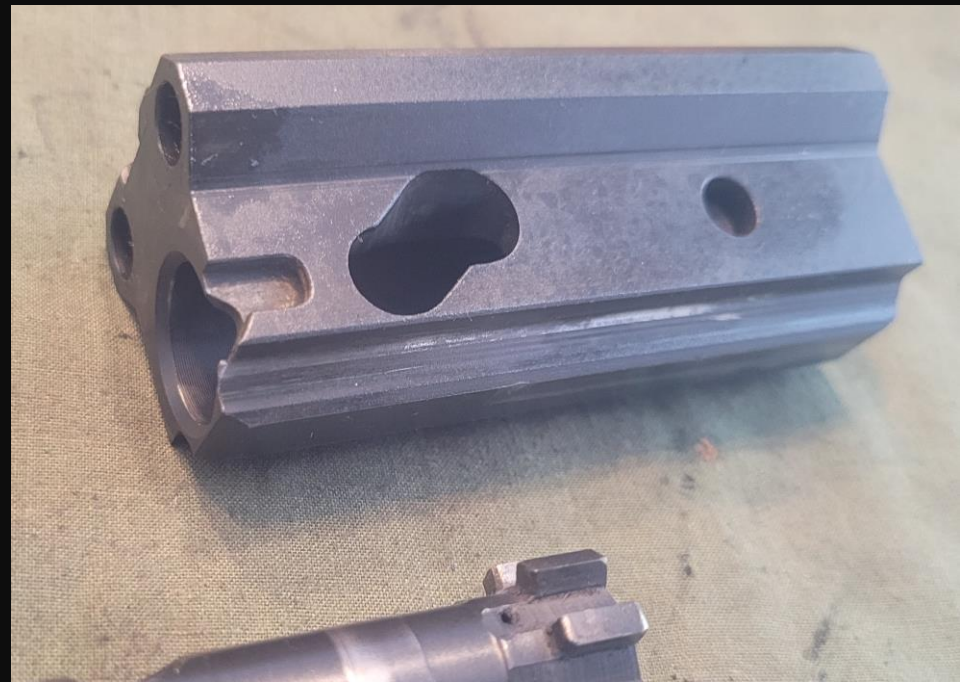
A look at the rifle (6)

The new gas system requires a different bolt carrier than the WK180 Gen 1 or 2

A newer longer firing pin is in use to combat hard primers

Cheap cotter pin should be replaced with a higher quality one

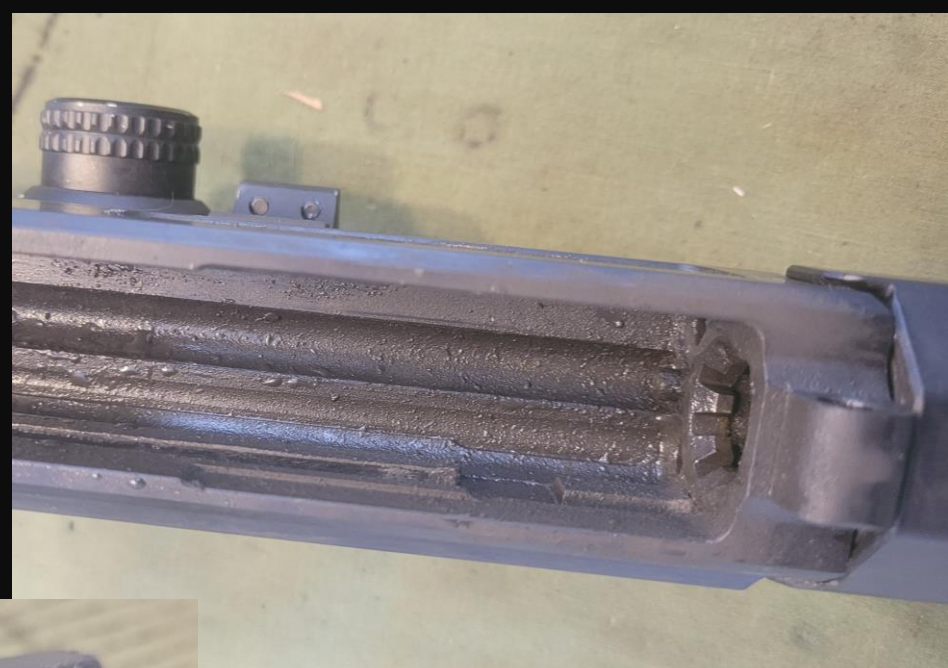
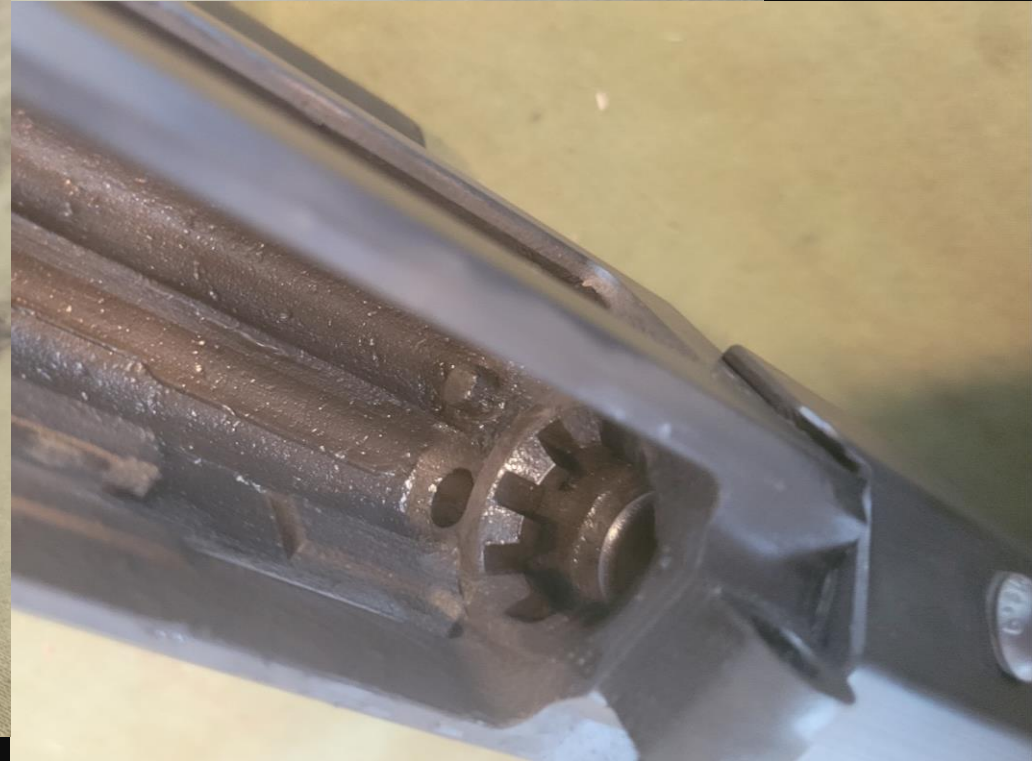
The rifle after 4476 rounds and 3226 without cleaning (1)

Water due to snow melt from cooling the rifle down

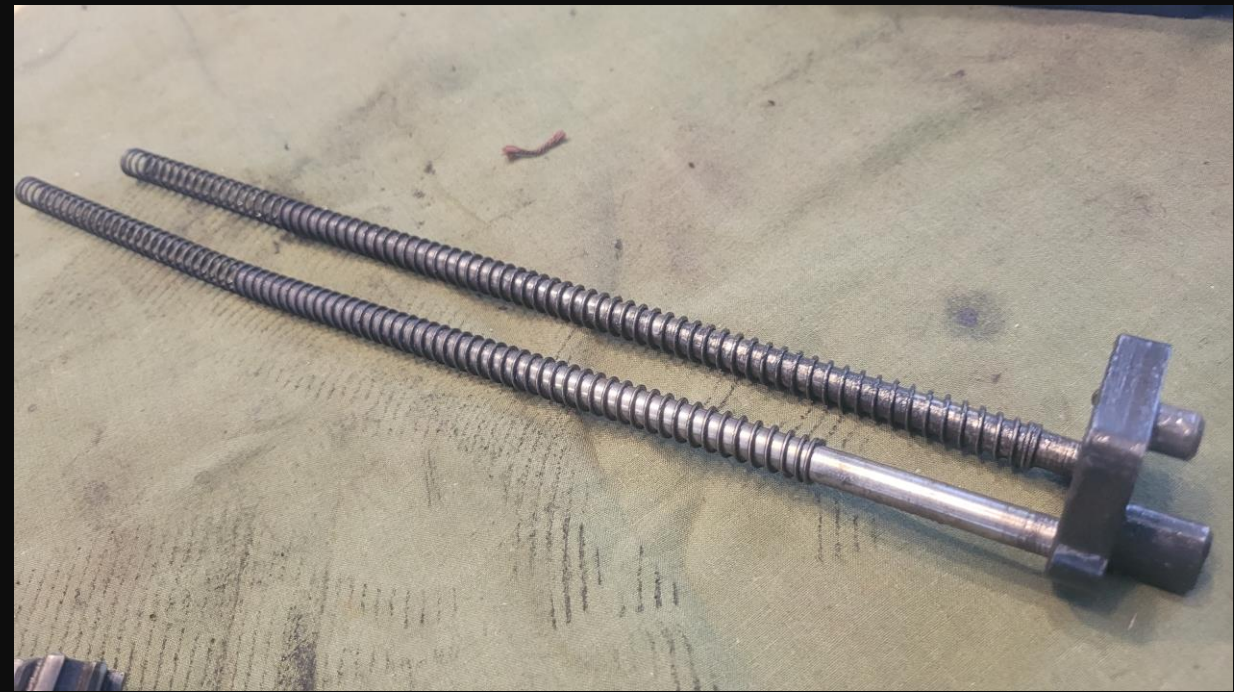
The rifle after 4476 rounds and 3226 without cleaning (2)

The recoil springs have started to shorten (Bottom 2 are WK181 springs, remainder are un-used 180 springs)

On the WK180 this contributed to the gun self-disassembling while shooting

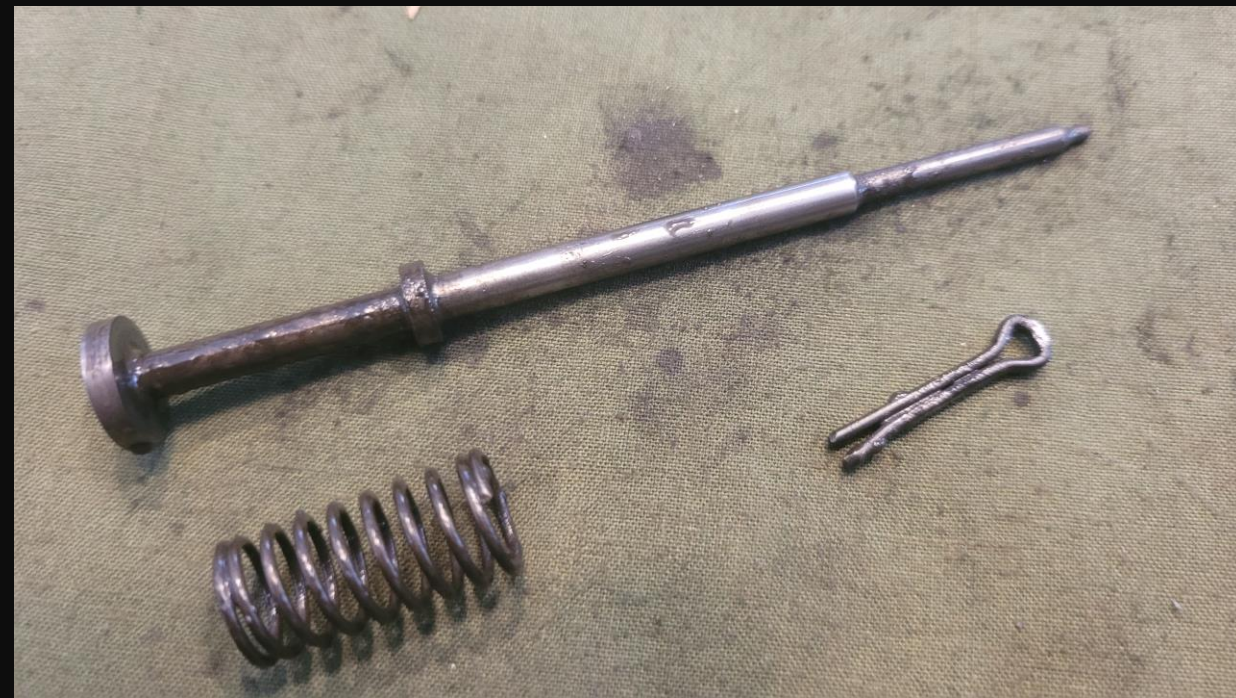
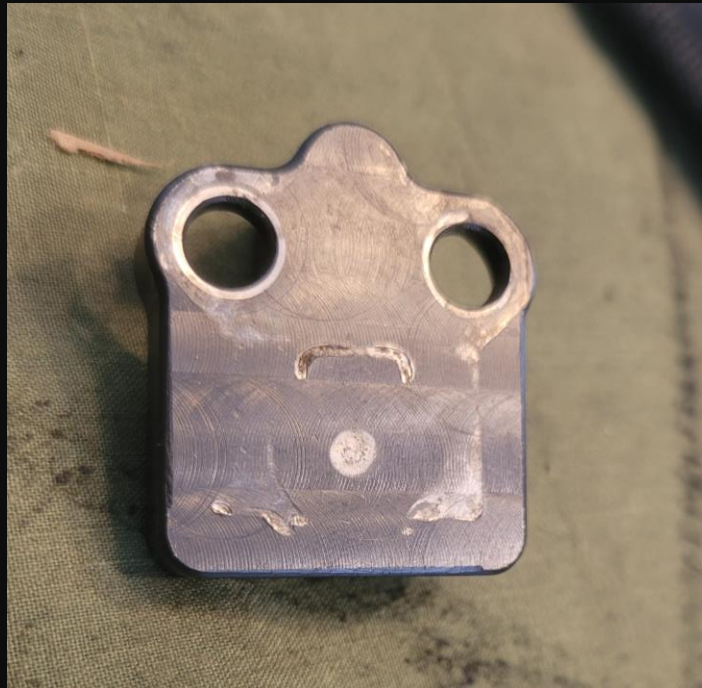
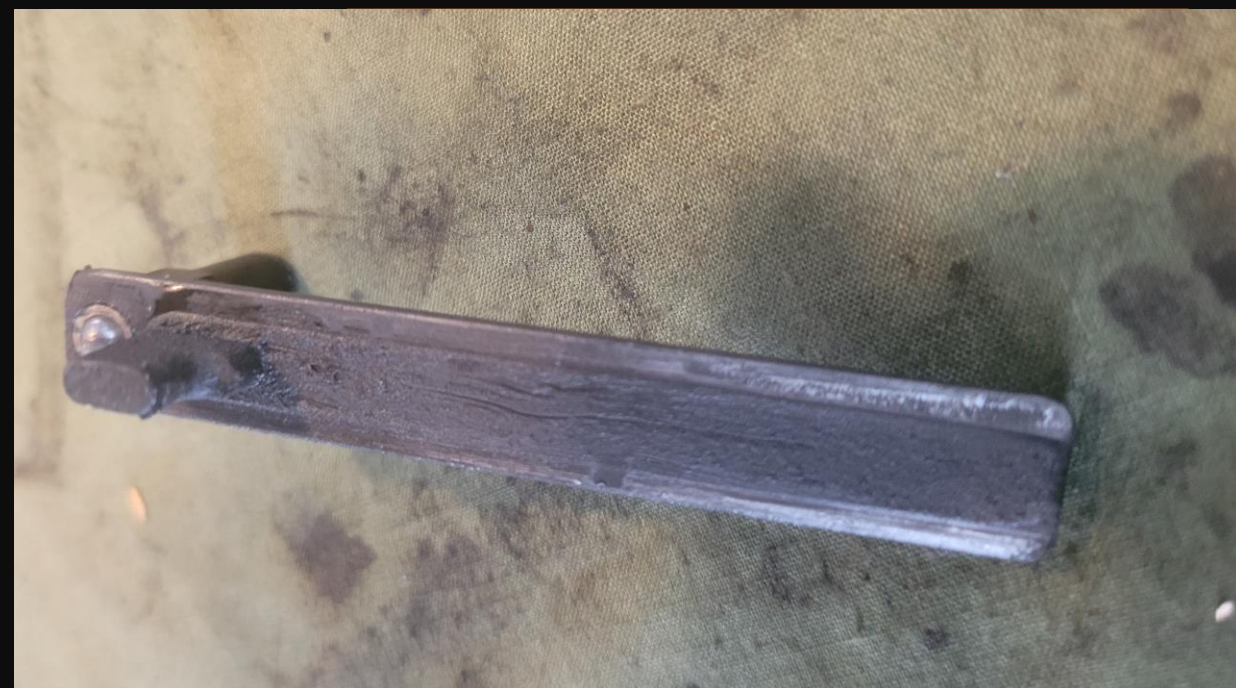
The rifle after 4476 rounds and 3226 without cleaning (3)

Firing pin assembly was not too bad,

The bread slice has indentations from the BCG hitting it

The cocking handle while dirty had no functioning issues beyond the plastic cover coming off

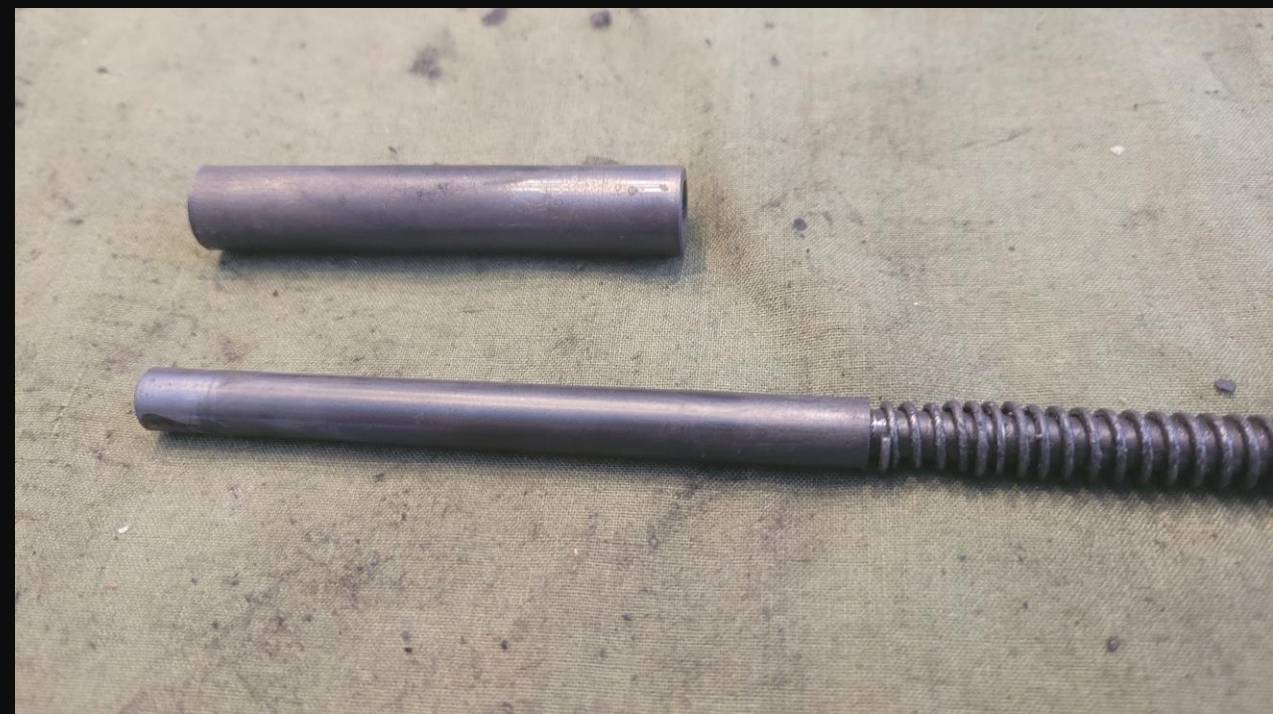
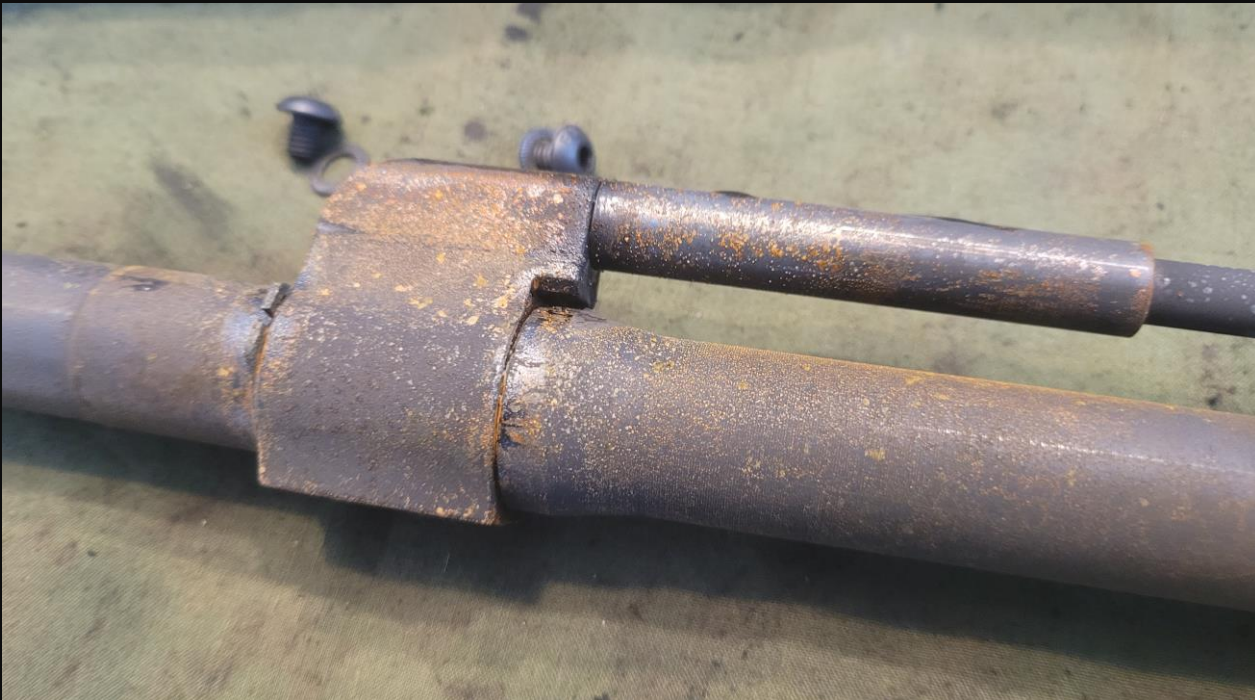
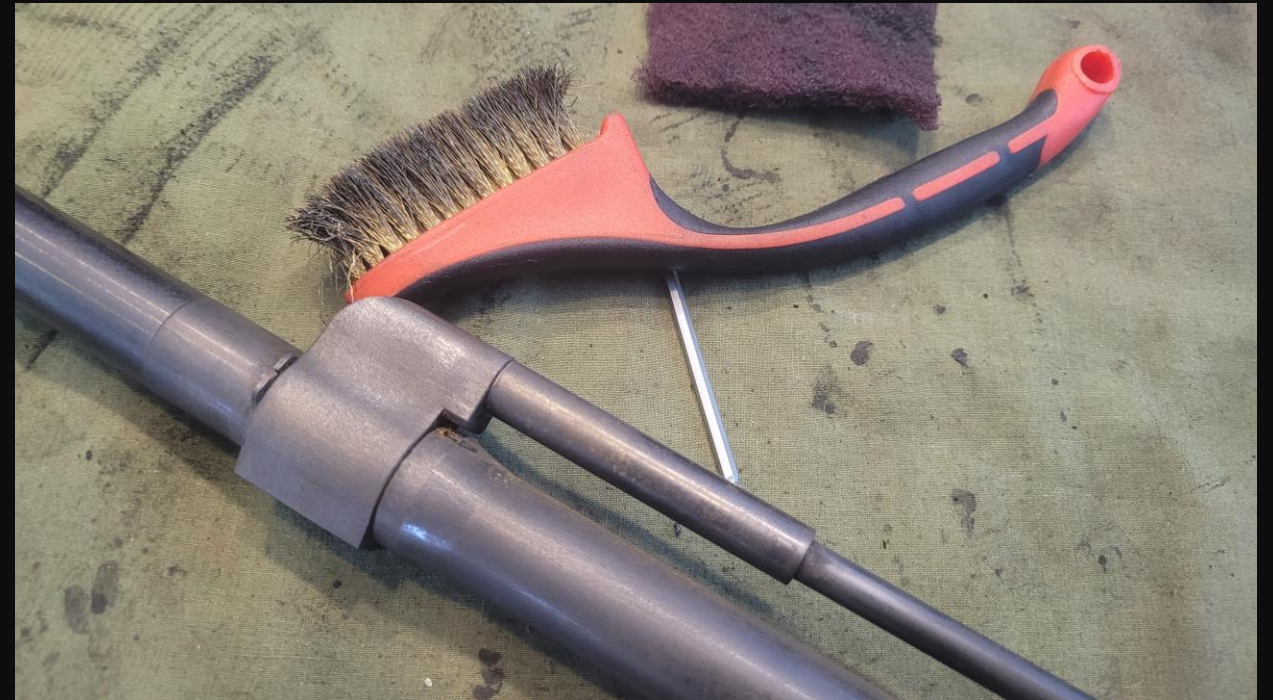
The rifle after 4476 rounds and 3226 without cleaning (4)

The gas system was surprisingly clean

The rust came from heating the gun up VERY hot then using snow to cool it down on a humid wet day at about +2c

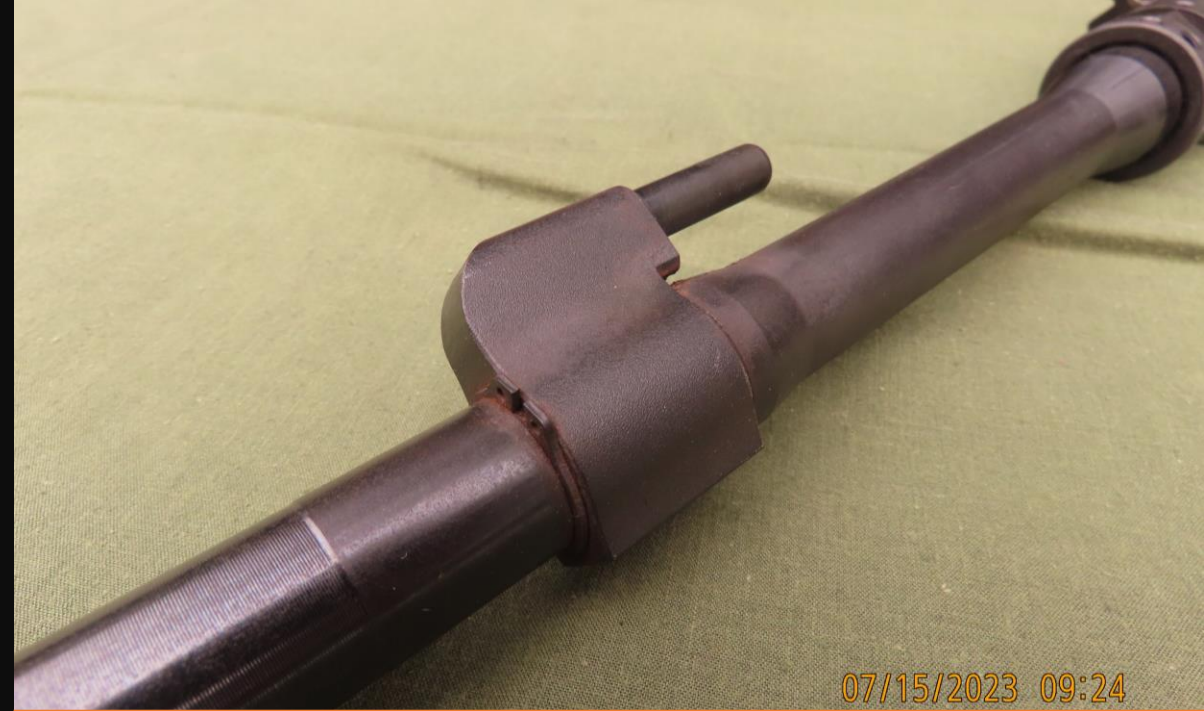
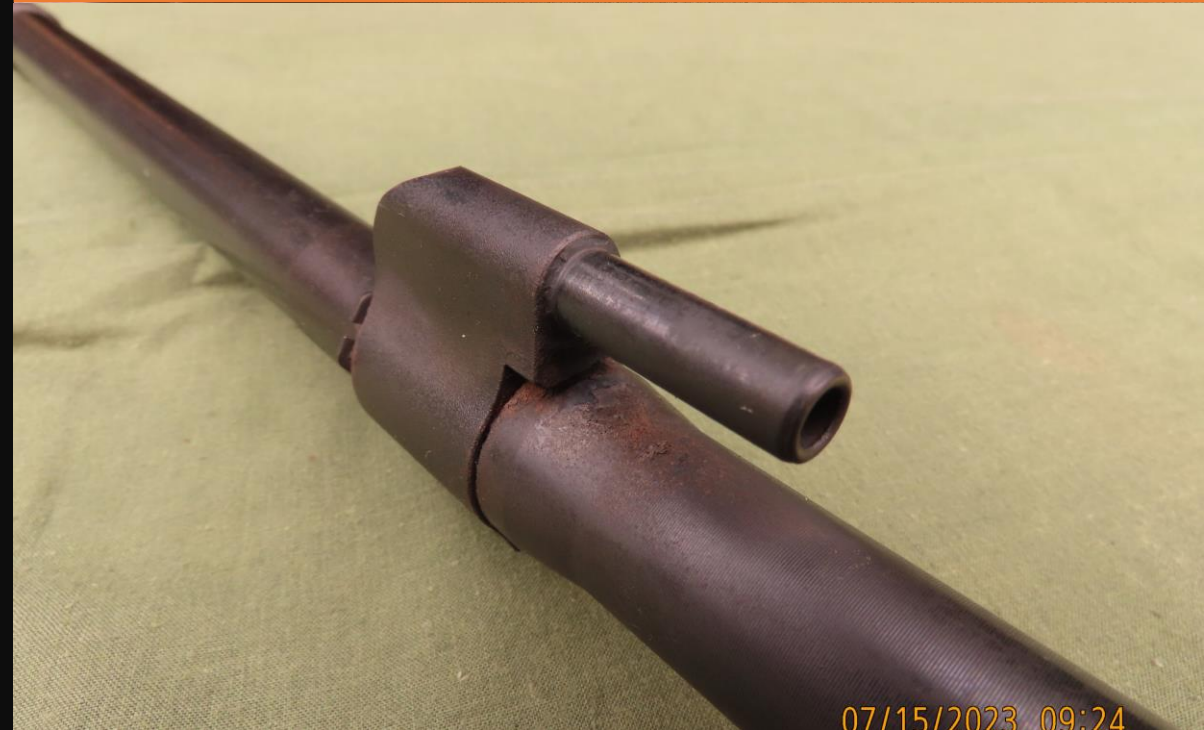
Gas Block

The coating on the metal of the gas block however is rust prone but cleaned up nicely
