WK181 10K Endurance Test Full Review

A Canadian Firearms Endurance
Testing Report

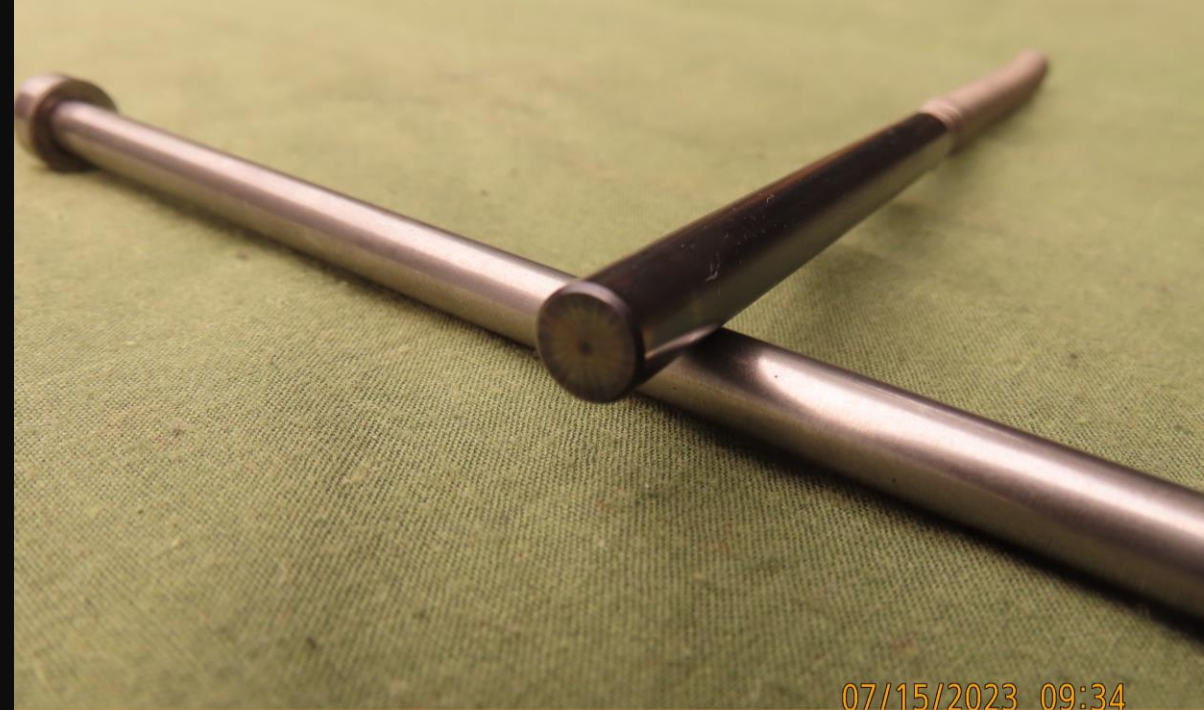
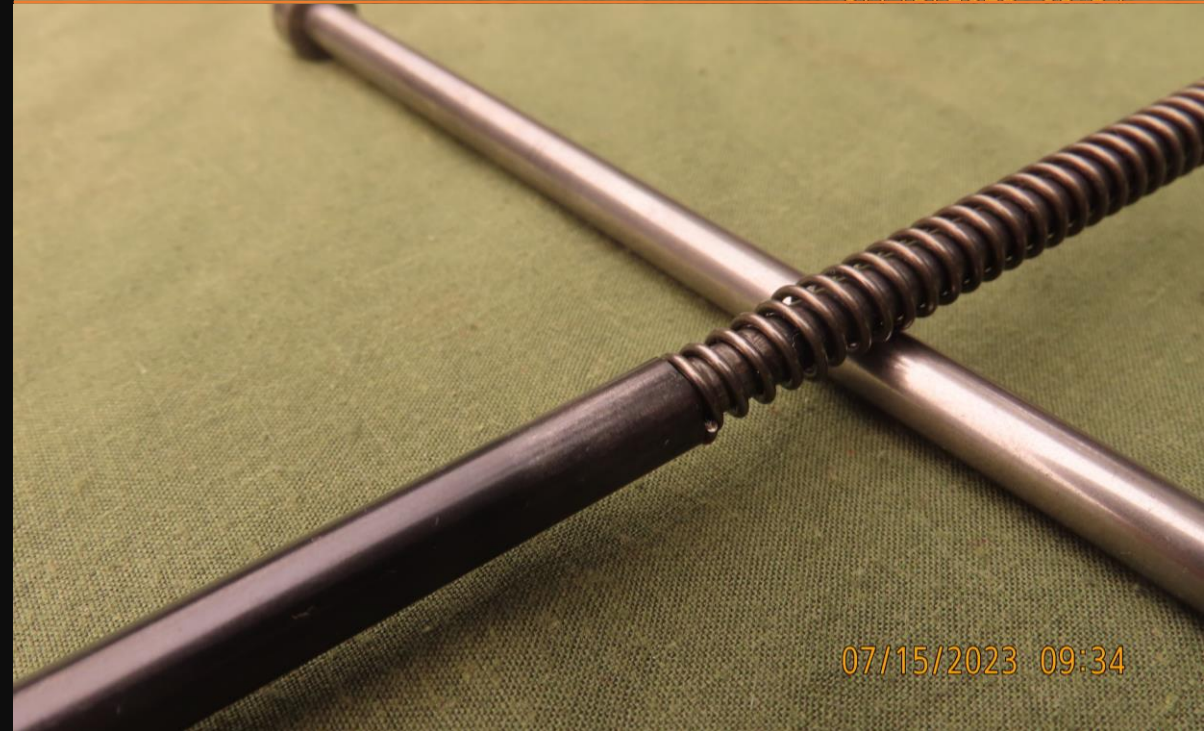
Gas piston

At 8730 rounds it was noticed that the piston spring had broken.

It is noted that on compression the piston spring rubs against the barrel nut and has actually cut a small groove into it.

It was also noted that the piston spring may be being stretch during use from it's rubbing against the barrel nut. Looking at where the first piston spring broke it was in a similar place to the highlighted stretched area

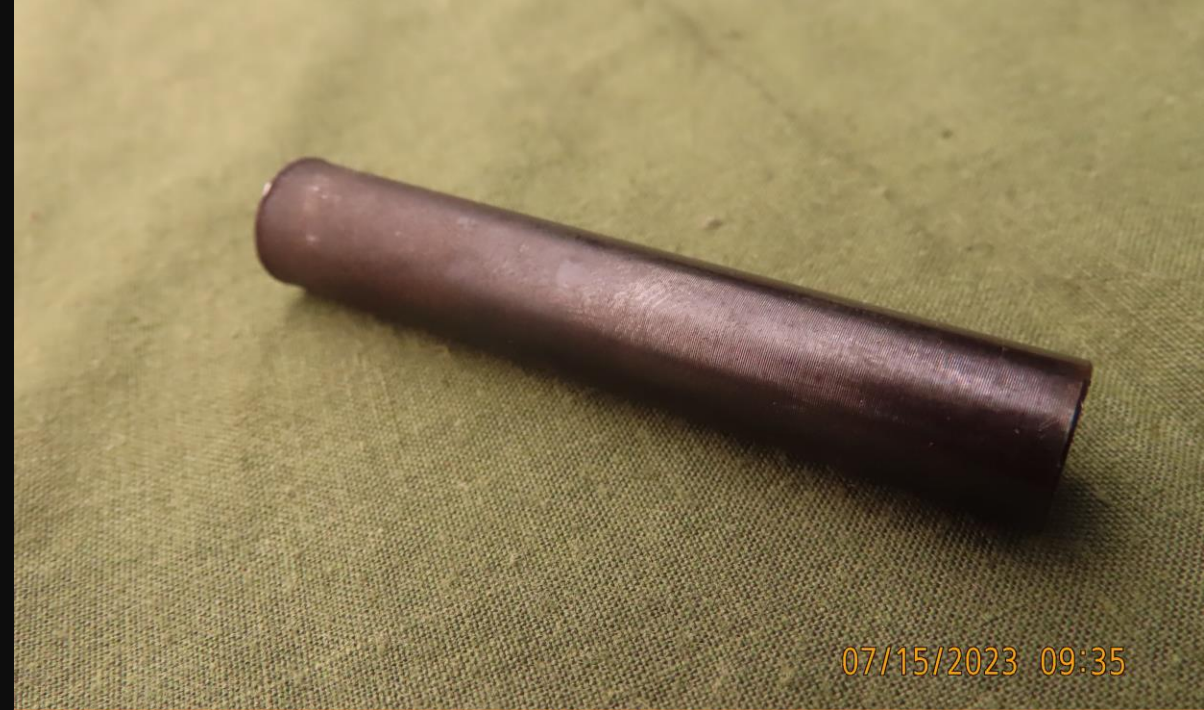
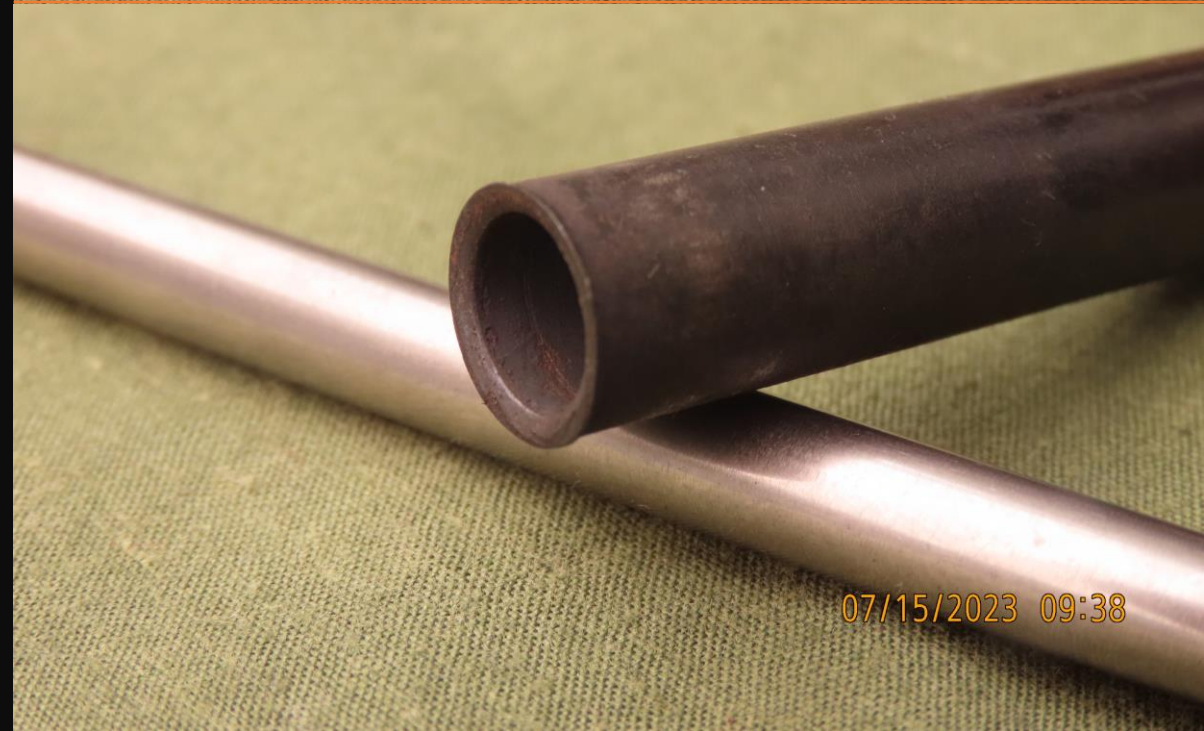
Gas cup

It also noted that by 8730 rounds the gas cup has started to mushroom from repeated impacts against the gas block.

We have not seen any issues directly attributable to this, had the cup cracked we might have.

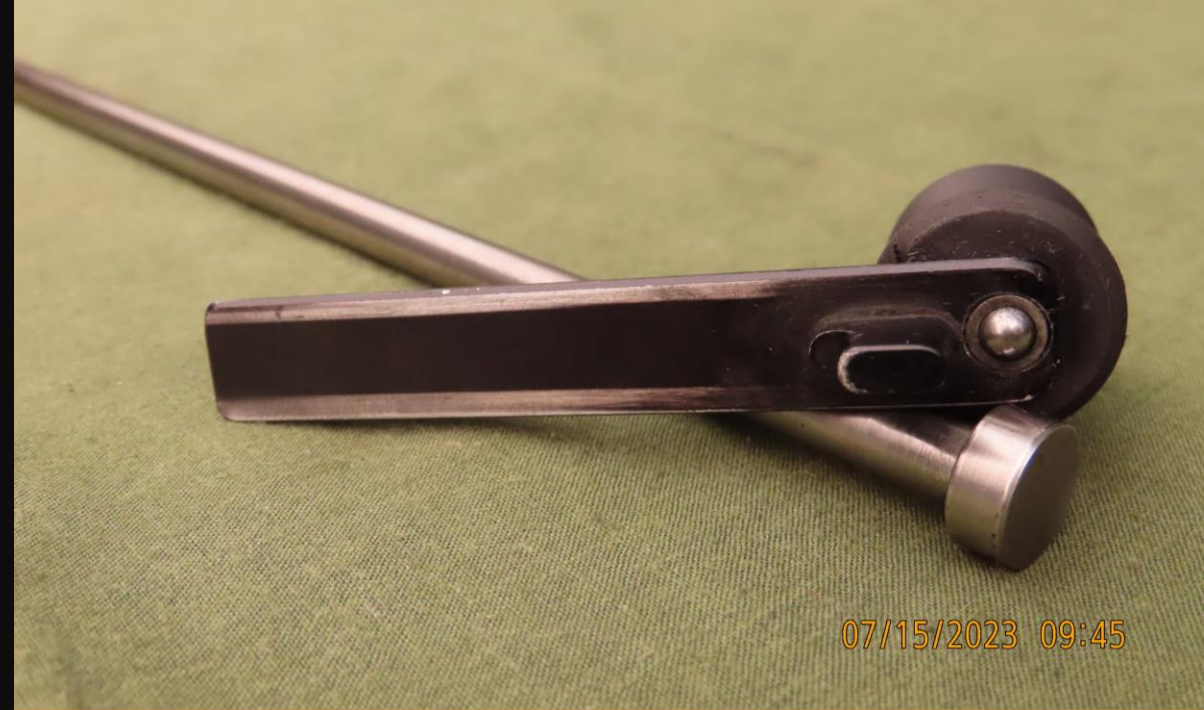
Cocking handle (NB: This is not the original, the first was replaced after the plastic cover came off within <1000 rds)

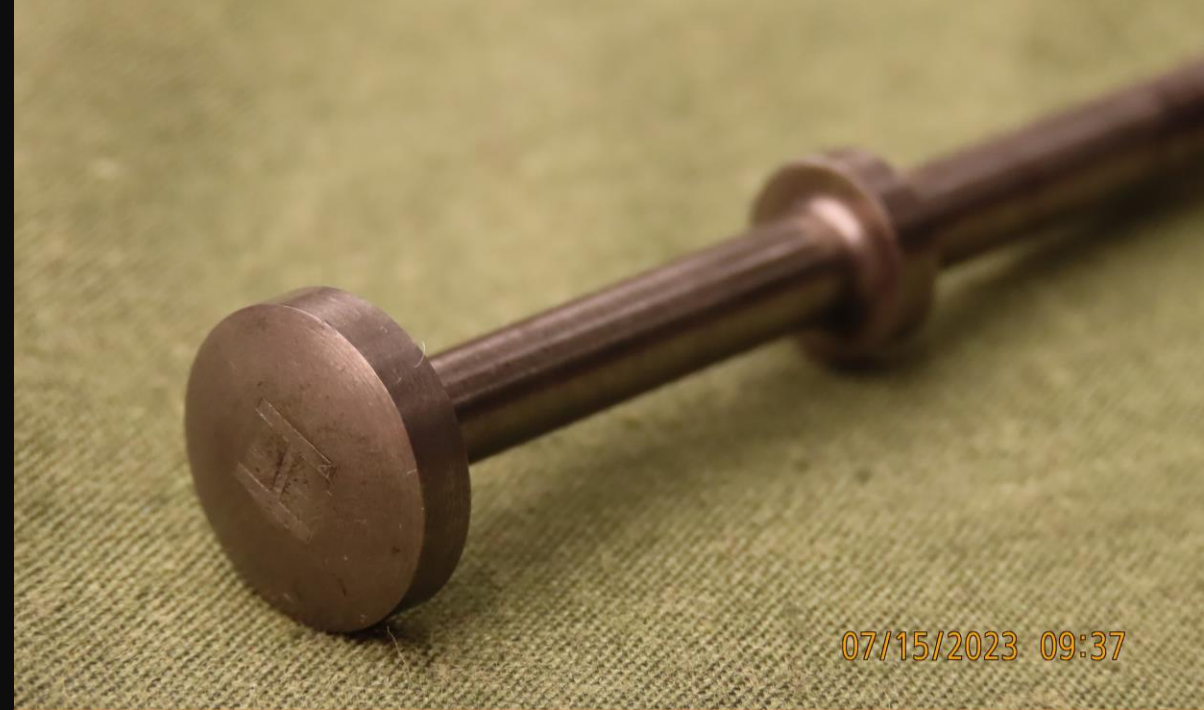
Firing pin and Cotter pin (which had equal wear on both sides and was a replacement part after the first broke)

Cheap cotter pin should be replaced with a higher quality one
